Bridge Inspection

Bridge File Number	72515 -1 Bridge	Form Type	TH
Year Built/Year Supstr	1946/1946	Lot No.	3
Bridge or Town Name	GOODRIDGE	Inspector Name	MARIO AMERO
Located Over	BEAVER RIVER, 7, WATERCRS-ST	Inspector Class	
Located On	LOCAL ROAD	Assistant Name	
Water Body Cl./Year		Assistant Class	
Navigabil. Cl./Year		Inspection Date	OCT 25 - 2022
Legal Land Location	NE SEC 6 TWP 63 RGE 8 W4M	Arrive Time	16:55
Longitude, Latitude	-111:11:32, 54:25:23	Depart Time	18:20
Road Authority	M.D. OF BONNYVILLE NO. 87	Data Entry By	Theresa Lacusta DEC 0 1 2022
Contract Main. Area	UNDEFINED CMA	Data Entry Date	
Clear Roadway/Skew	4.9 /	Reviewer Name	Wade Nanninga 3 0 NOV 2022
AADT/Year	150 / 2021 (E)	Review Date	
Road Classification	RLU-208G-90	Dept. Reviewer Name	
Detour Length (km)	2	Dept. Review Date	
Follow-Up By			
Allowable Load (t):	Single H 20 FLOOR BEAM	Semi HS 27 U2L3	Train CS3 32 U2L3
			---> On Critical Spans --->Critical Member

Bridge File:	72515-1
Date:	October 25, 2022
Photos by:	Mario Amero
Stream Name / Highway Location:	Beaver River / Highway Local Road, Goodridge

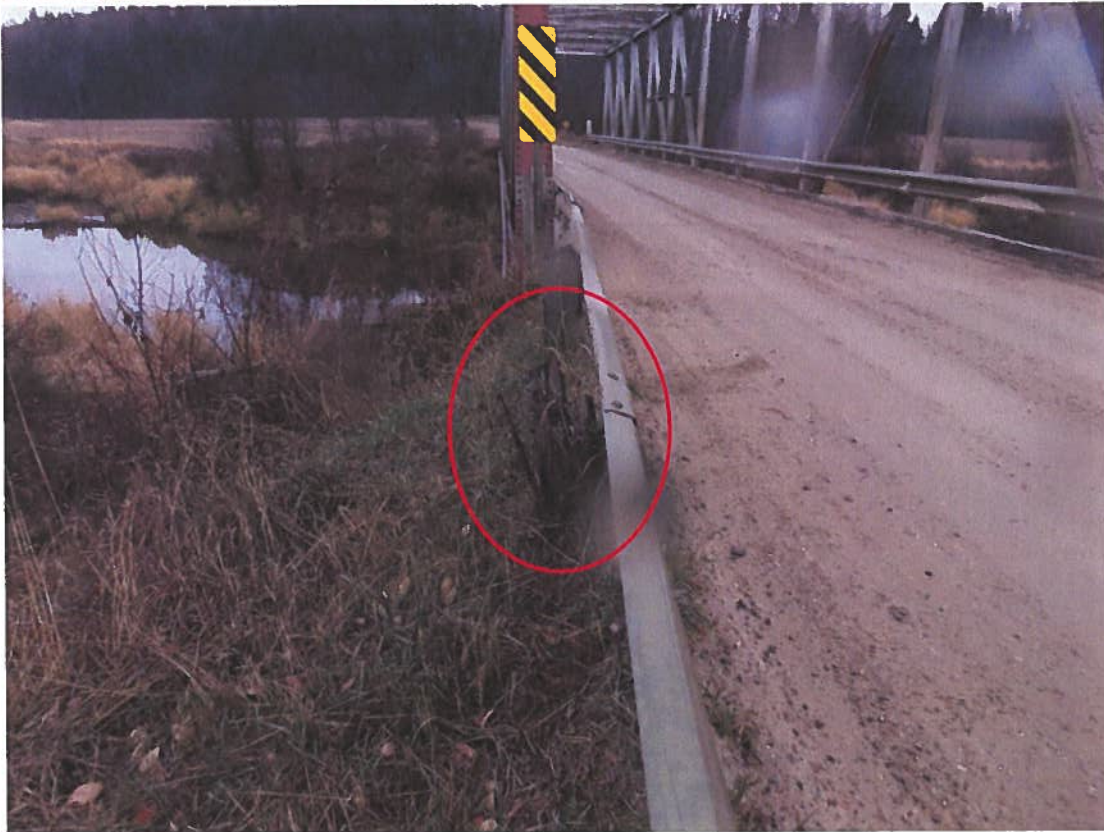
Broken guardrail post at n/e

Completed Work						
Planned Work						
Work Type	Status	Rec. Year	Target Year	Inspector Comments	Department Comments	
REPAIR/REPLACE BRIDGE RAIL	PRIORITY REQUIRED	2021 2022		Replace 2 TT guardrail posts and straighten.		
SEAL CURBS	PRIORITY ASSIGNED	2021 2022		Replace 10 wheelguard blocking and 1 WB plank 20' long.		
PATCH DECK	PRIORITY REQUIRED	2023 ✓		Strip deck in wheel path ~100m, patch/grade potholes.		
STRAIGHTEN/REPLACE MEMBERS	PRIORITY ASSIGNED	2021 2022		Drill out & install bolt @ NW batter post & floor beam. Replace U2L3W, and dented sway brace(1).		
OTHER ACTION	PRIORITY REQUIRED	2021 2022		Grind and touch up vehicle scrapes on U0L1E, U2L2W and U3L3W, & WLD/HLD nicks~10 total.		
OTHER ACTION	PRIORITY REQUIRED	2021 2022		Reset Hazard markers.		
OTHER ACTION	PRIORITY REQUIRED	2021 ✓ 2022		Install speed limit 30 kph, Stop if Oncoming Vehicle on Bridge Signs. ✓		
OTHER ACTION	PRIORITY REQUIRED	2021 2022		Sandblast/paint stringers/floor beams @ abutments ~150m2.

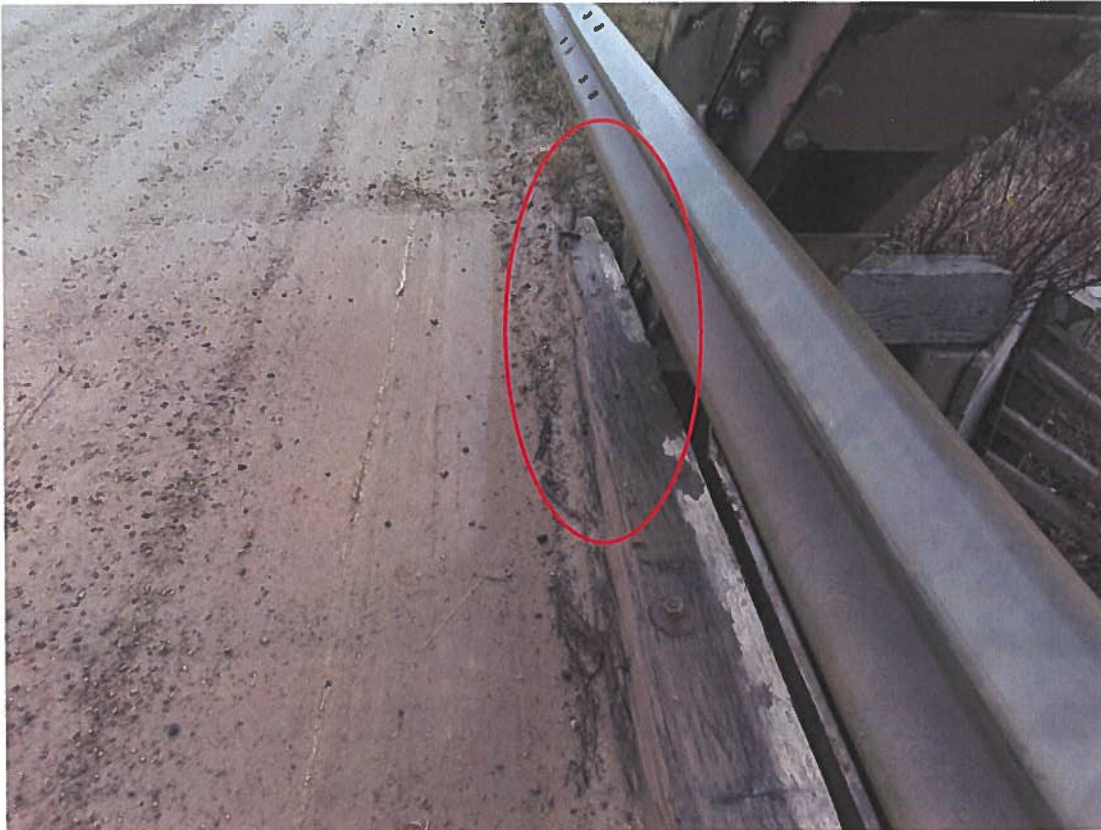
Damaged wheel guard at n/e

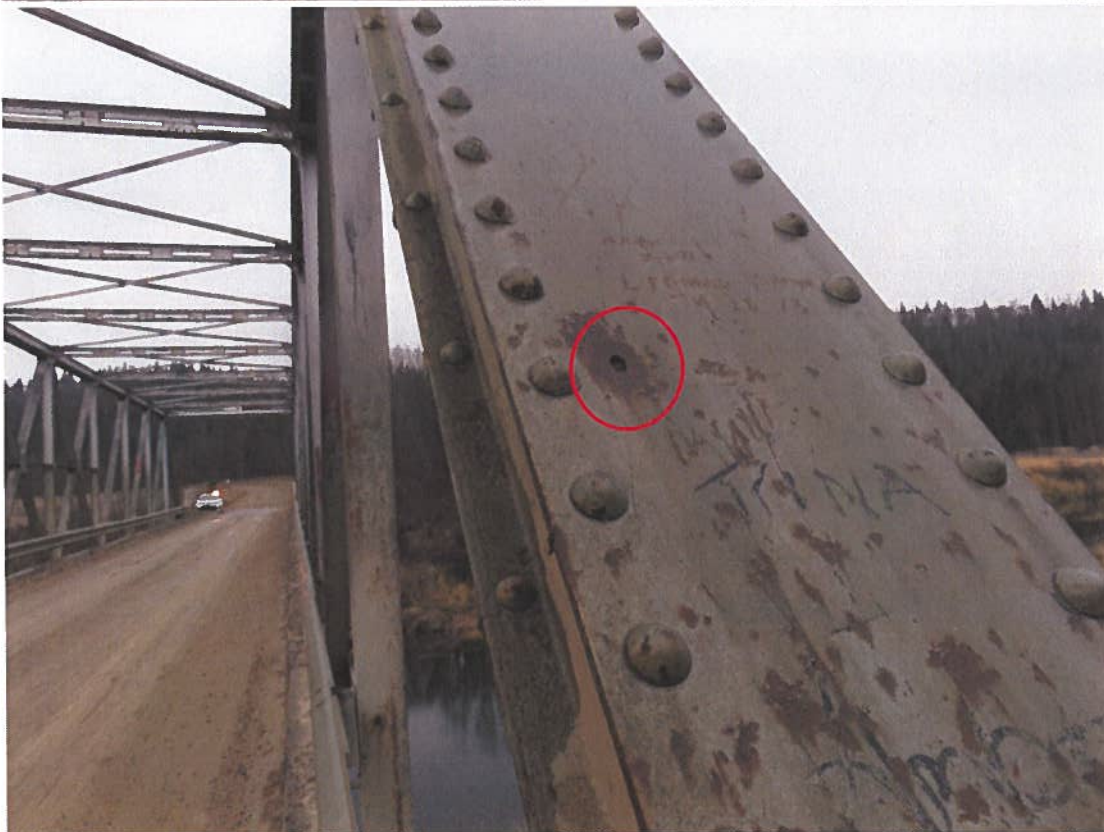
Superstructure						
Bridge Component			Last	Now	Explanation of Condition	
(Primary Span : TH, 1 Spans, Lengths(m): 45.7, A-Ident Number: A0066-01)						
Wide Load Damage (Y/N)	Yes				Bullet hole NW batter post. ✓ (U8U8 crack @ lower weld @ W end. 11-Jun-07) ← All top bracing welded @ mid length ✓ U3L4W-30mm kink @ mid length. (U1U1-2 nicks & dents on lower flange. U9U9-5 x 150 dent. U1L1W headless rivet @ L1W. U9L9W-2 malform rivets @ U9W. L8L9E-3 headless rivets @ L8E. L4L5W-6 headless rivets @ L5W. L0L1W-11 x 350 dent o/s flange near L0W.-Nov, 2018) Scaling up to 2mm deep on lower flange only @ ends of beams. ✓ Rust scaling bottom flanges. Scaling lower flanges at abutments, minor. (U1L2W viewed from deck & U1 outside has possibility of crack. 17-Apr-18) (Headless rivet L8L9W @ L9.-Nov, 2018) Recent accident damage to U2L3W with rail bolt pulling through bolt hole & overall kink of ~50mm. ✓

Bullet hole in n/w batter post

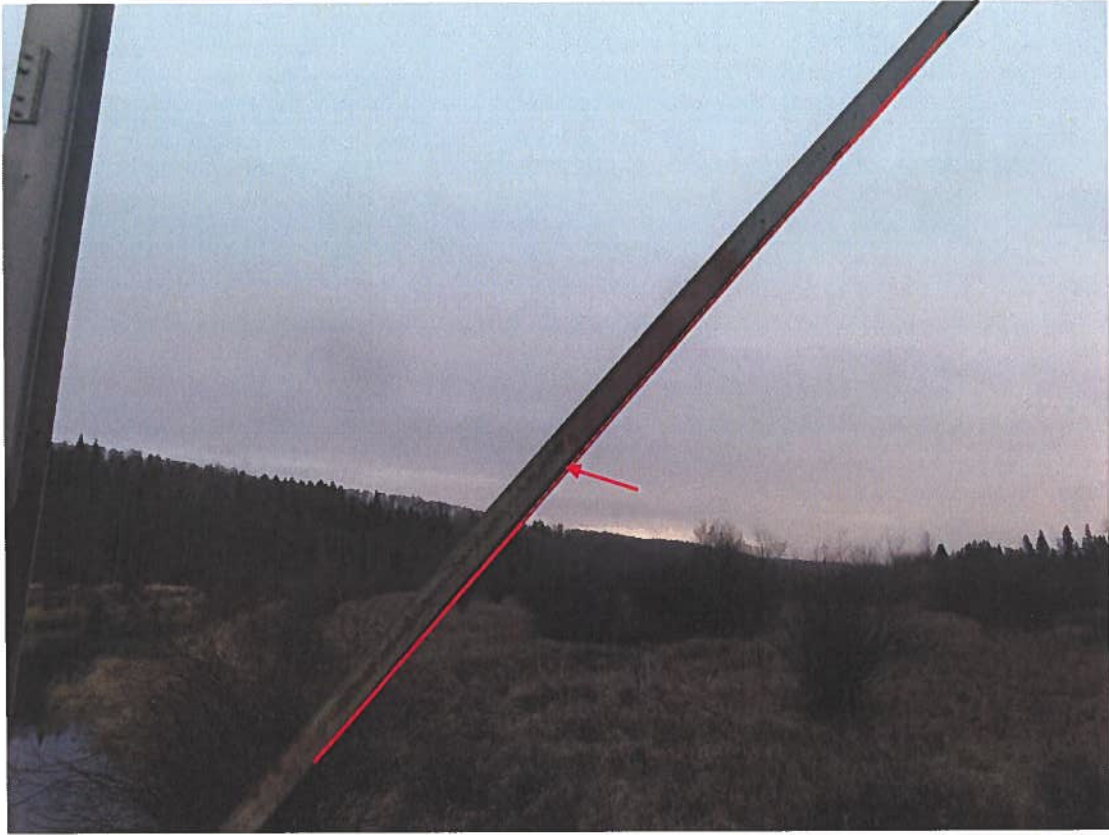
U2L3W- slight bend

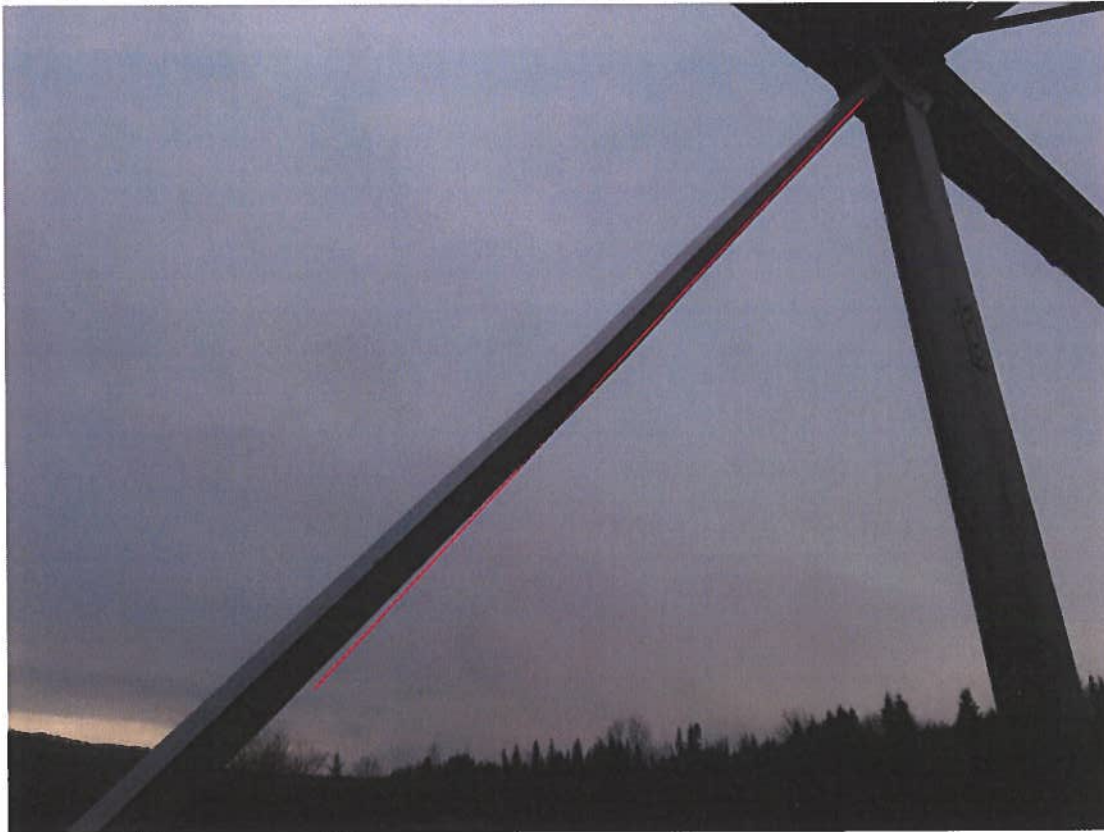
U3L4W- bend/twist

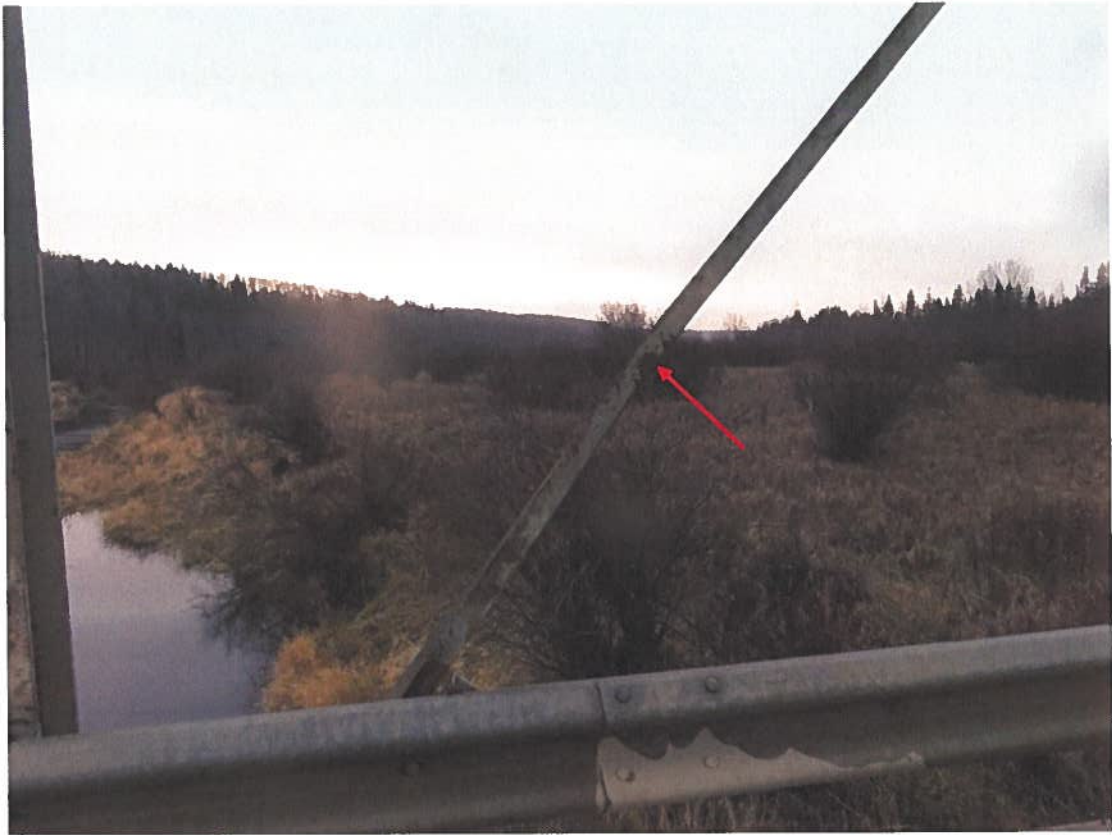
U2L3W- bent diagonal

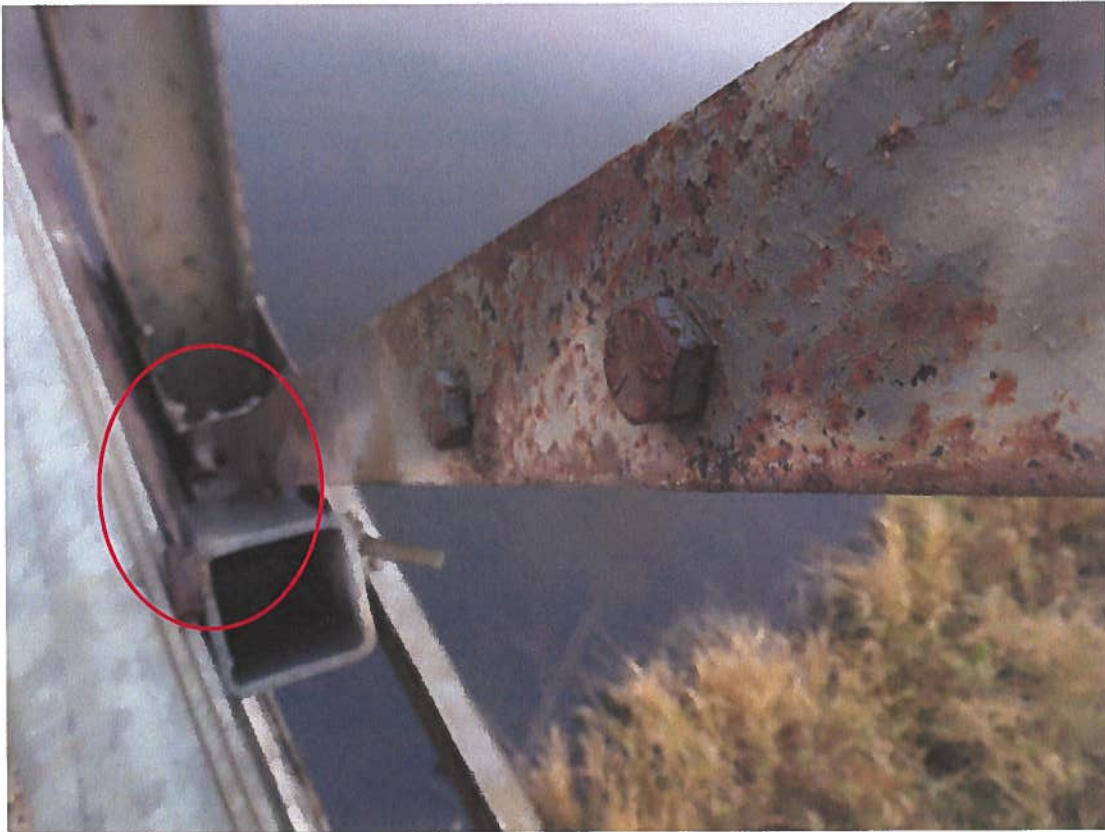
U2L3W- broken bolt connection

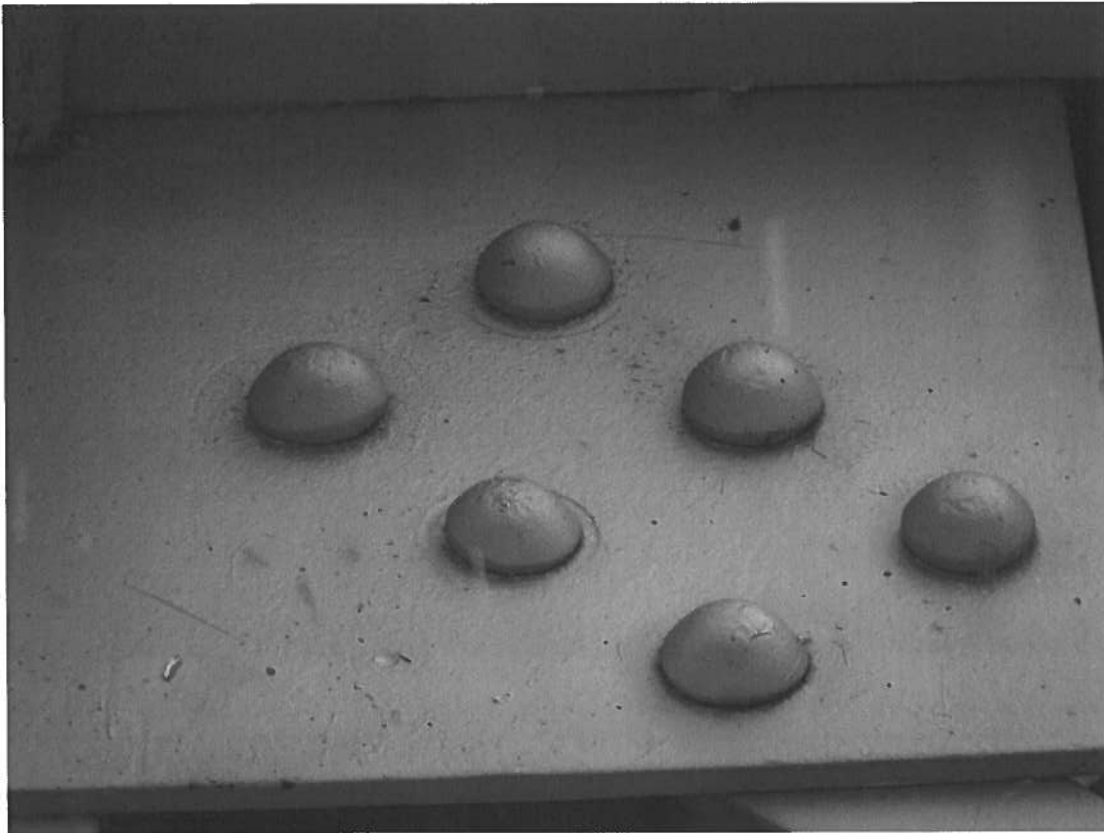
U8U8WConnection

Structural Condition Rating (Last/Now) (%)		50.0/	Sufficiency Rating (Last/Now) (%)		33.5/	Est. Repl. Yr	2030 /	Maint. Req. (Y/N)	Y
Special Comments for Next Inspection	Monitor lower weld on U8WU8E. (Local residence stated that heavy gravel trucks are crossing bridge load on regular basis - Feb 19, 2015). No repair for jammed beams at this time.				Department Comments	HUC6 BOUNDARY: UPPER BEAVER RIVER; RISK ZONE: WHITE			
Previous Inspector's Name		Wade Nanninga			Previous Assistant's Name				
Next Inspection Date		31-Aug-2024			Previous Inspection Date		31-May-2021		
Inspection Cycle (Default) (months)		39							
Comment

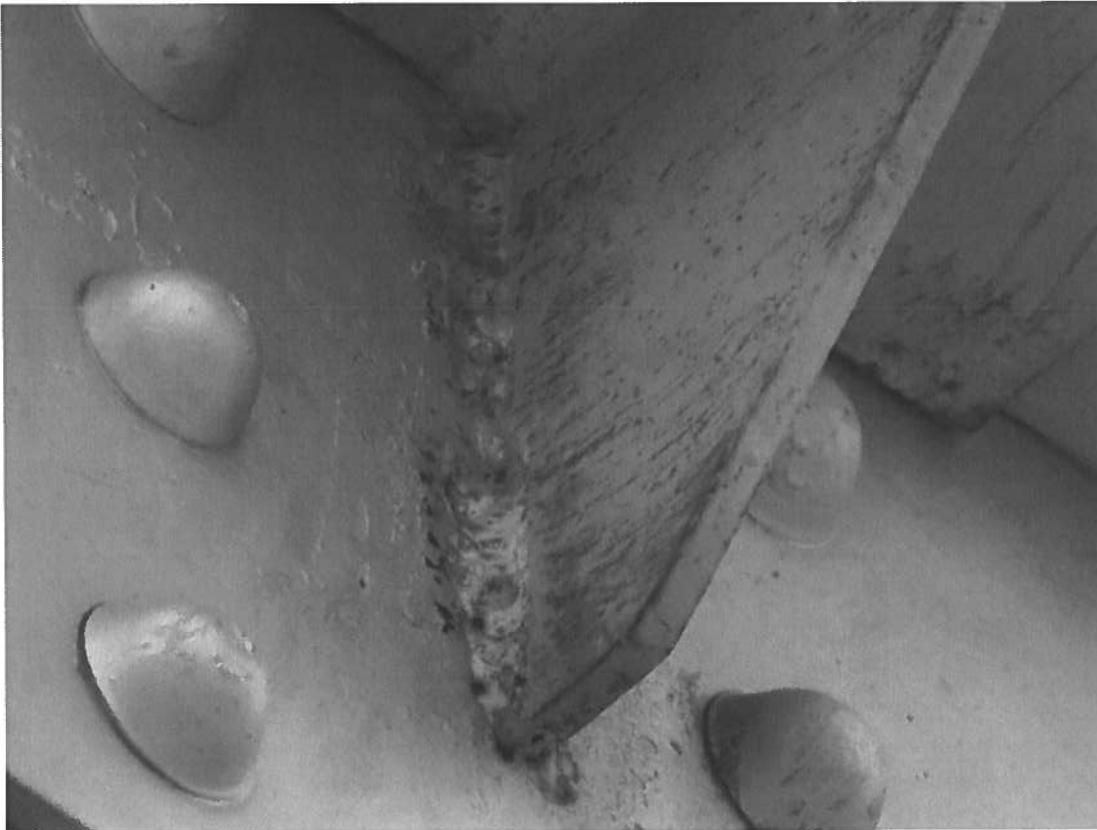
U8U8W welded connection, south view

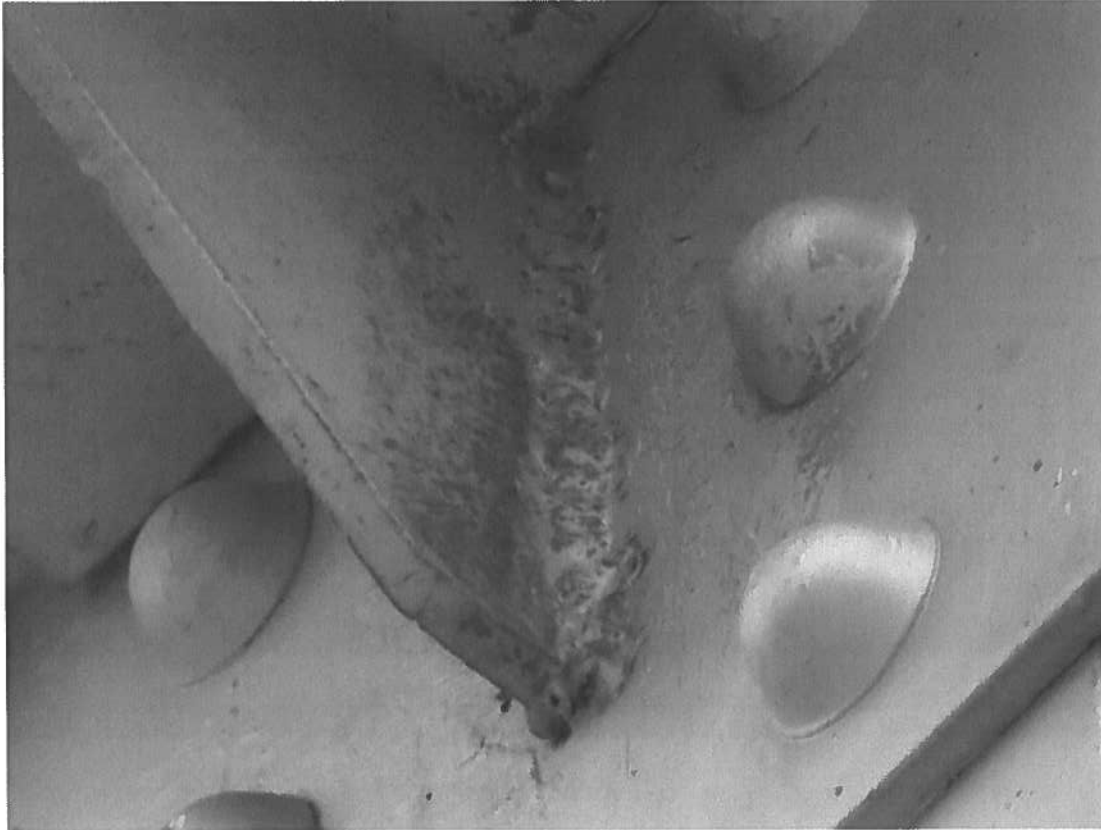
U8U8W welded
connection-north view

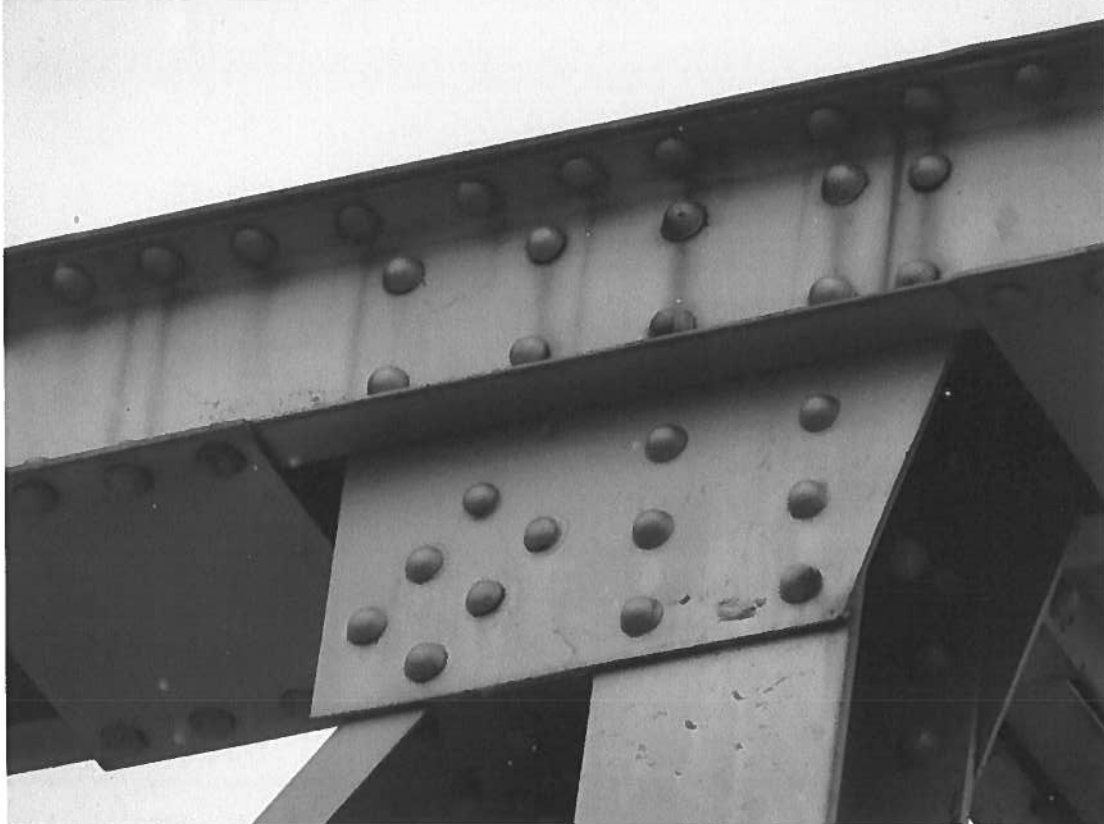
U8U8W exterior
connection
