**New Report Assists Water Utilities with Infrastructure Asset Management, Pipe Repair, and Replacement**

December 2023

A Resource to Support Asset Management,  
Pipeline Renewal, and Replacement

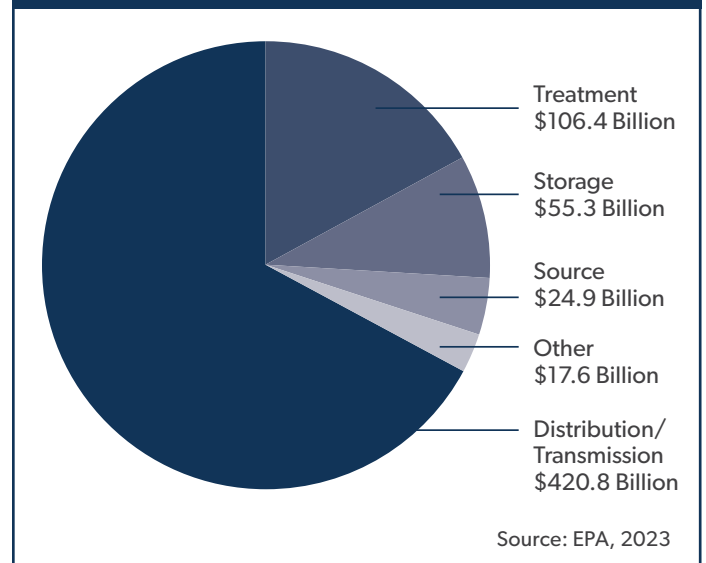
FIGURE 1: TOTAL 20-YEAR NEED BY INFRASTRUCTURE PROJECT CATEGORY (2021 DOLLARS)

According to the EPA's Drinking Water Infrastructure Needs Survey and Assessment (DWINSA), the estimated 20-year national drinking water need is \$625 billion (EPA, 2023). Figure 1 clearly shows that the total anticipated cost to maintain underground distribution and transmission pipelines, at \$420.8 billion, represent more than 60% of the water industry's total funding requirements. Similar proportional costs are anticipated for Canada. This funding requirement for the next 20 years is necessary to provide safe drinking water to the public and includes installation of new drinking water pipelines, rehabilitation, and replacement of existing buried pipe infrastructure.

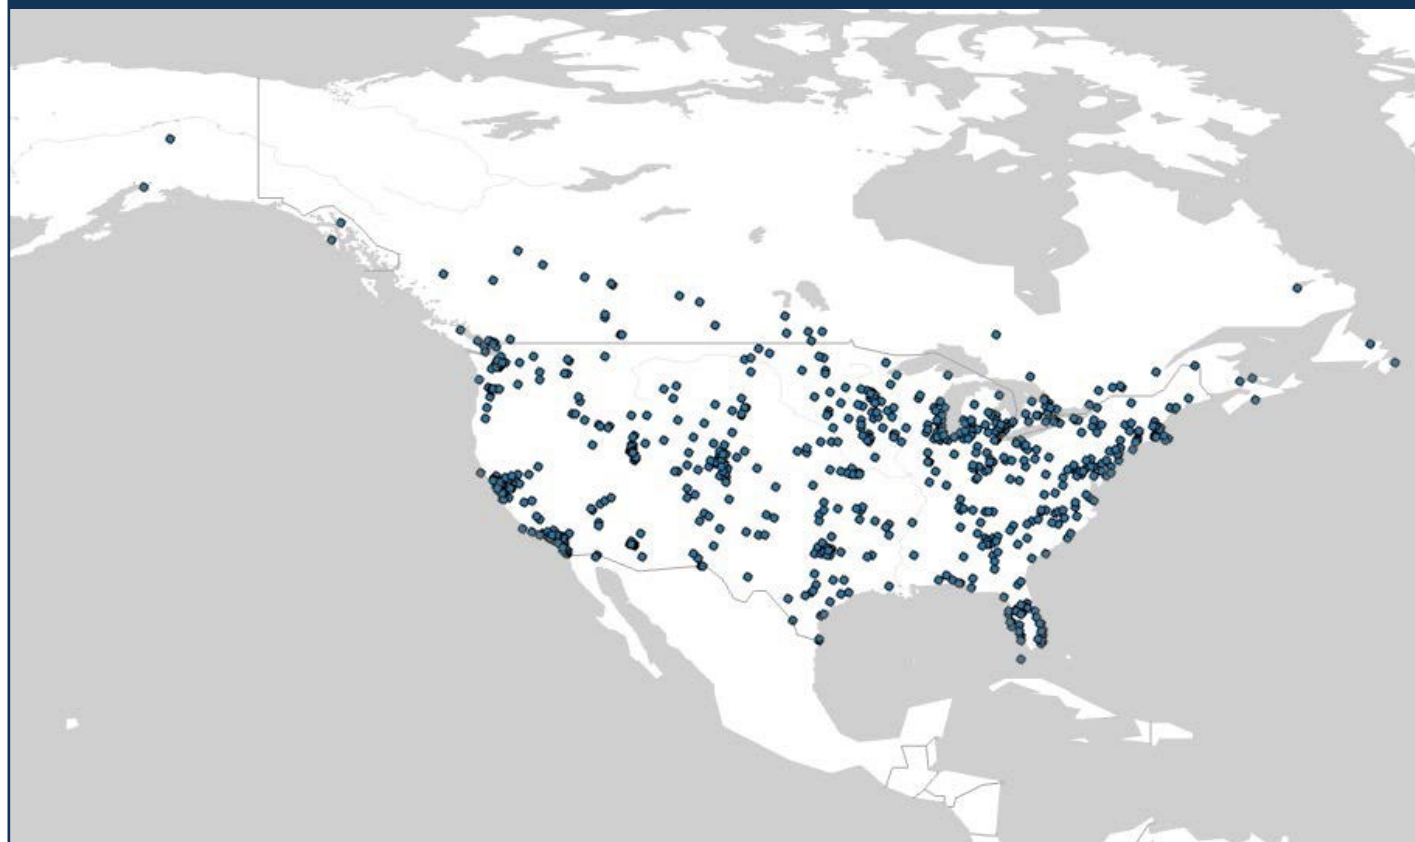
FIGURE 2: GIS MAP SHOWING UTILITY RESPONDENTS THAT PROVIDED GEOREFERENCED DATA

Although the surveys were collected in 2022, this report refers to the results as the “2023 study” to correspond to when the data were tabulated and analyzed. This included data quality control, follow-up phone calls, and data validation. The basic survey participants were asked for data from the previous 12-month period (2021 – 2022) as well as a previous 5-year period (2017 – 2022). A total of 802 basic survey responses were received from 49 of the 50 US states and all 10 Canadian provinces (Figure 2). Of the 802 utilities:

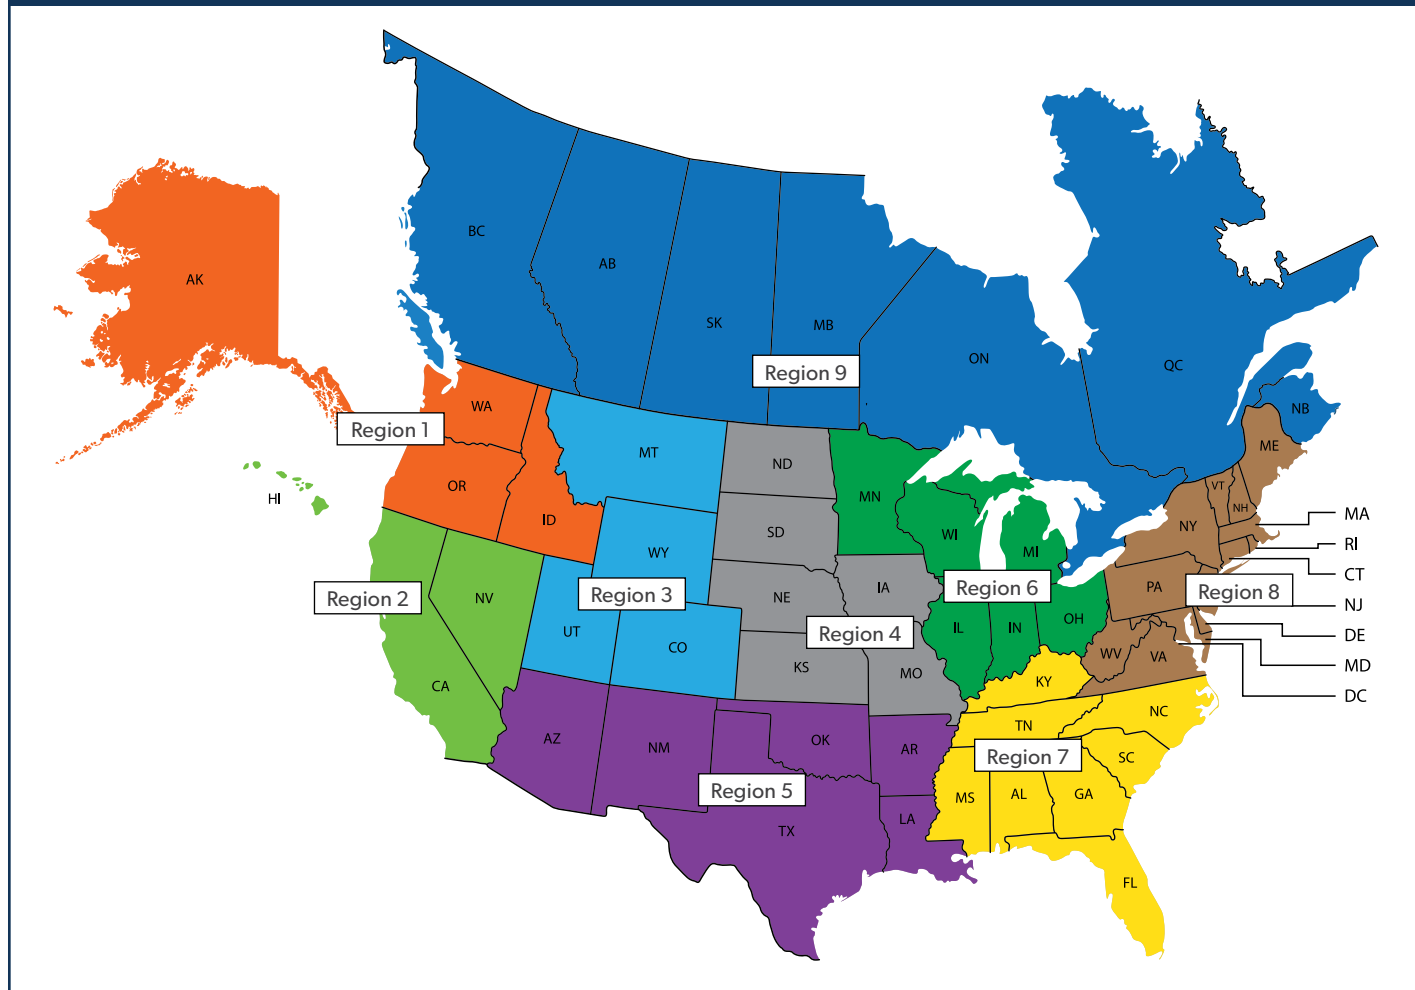
FIGURE 3: REGIONS USED TO REPORT SURVEY RESULTS

For this study, the US and Canada were divided into nine regions (Figure 3). Basic survey respondents were categorized according to region and utility size based on total pipe miles. The study represents 399,812 miles of pipe as shown in Table 1. This report provides results from both basic and detailed surveys and draws from other relevant industry sources.

To facilitate direct comparisons with previous USU surveys, nine survey regions in the US and Canada were utilized (Figure 3). The regions are used to indicate geographical variations. In total, 791 utilities provided pipe distribution data. Table 1 lists the number of respondents with pipe material distribution data, the miles of pipe, and the population served in the basic and detailed surveys from each region.

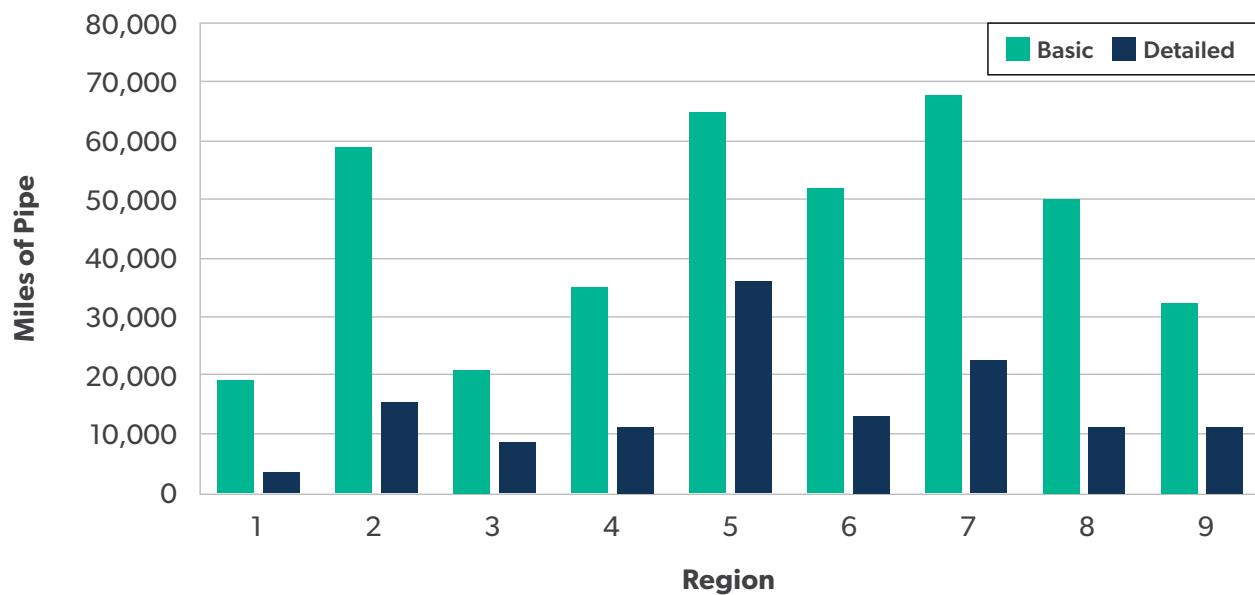
**FIGURE 4: MILES OF PIPE FROM EACH REGION FOR THE BASIC AND DETAILED SURVEYS**

Respondents were asked to report the length of water mains in their system but to not include gravity sewer pipe, sewer force mains, or water pipes less than 3 inches in diameter. Figure 4 illustrates the miles of water mains reported in the basic and detailed surveys on a regional basis. A total of 399,812 miles and 133,623 miles of pipe was reported in the basic and detailed surveys, respectively. Figure 5 illustrates the number of respondents from each region. Due to the large number of utility responses and the widespread representation and distribution from all regions shown in Figure 2, this is the most comprehensive water main break study to date.

As illustrated in Figure 4, Regions 5 and 7 reported the most miles of pipe from the basic survey. Figure 5 shows that the greatest number of respondents came from Region 6. Figure 6 shows the average miles of pipe per utility from the basic survey by region. Region 5 had the highest average pipe length at 783 miles and Region 3 had the lowest with 256 miles. The average miles of pipe represented per utility respondent is 505 miles (Figure 6) serving an average population of 146,432 (Figure 7). For comparison, the 2012 and 2018 surveys reported an average utility had 626 and 607 miles of pipe serving 164,325 and 186,752 people, respectively. The decrease in both average miles of pipe per utility and average population serviced seems to indicate a greater participation from smaller utilities for this study. The 2023 basic survey had 2.8 times more respondents and 2.34 times more miles of pipe than in 2018, increasing the statistical validity of this study.

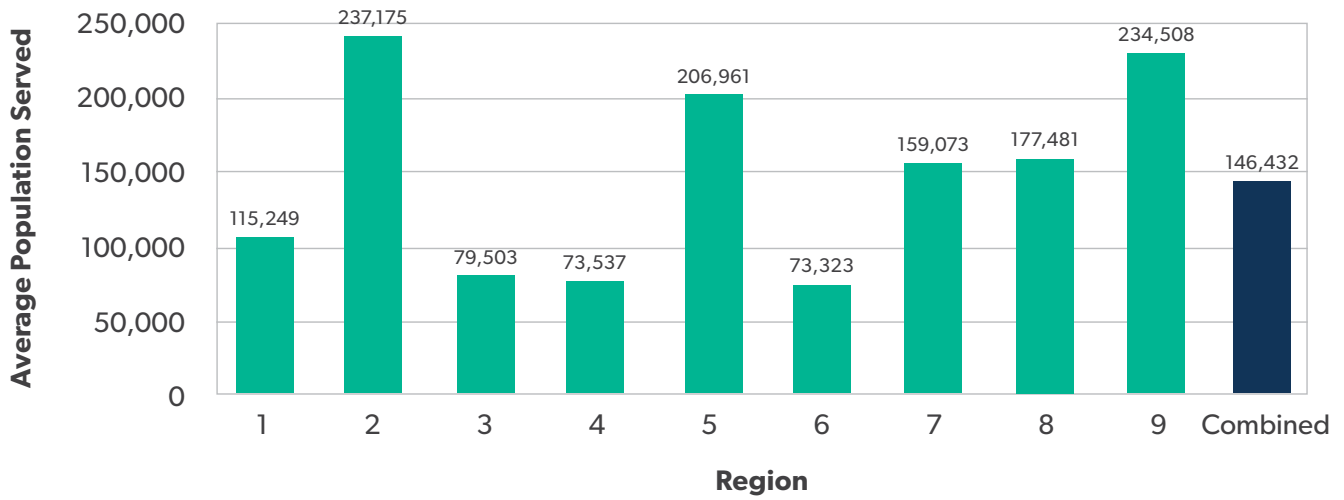
**FIGURE 7: AVERAGE UTILITY POPULATION SERVED BY REGION (BASIC SURVEY)**

Figure 7 shows the average population served per utility for each region. The average population served per utility for the basic survey was 146,432.

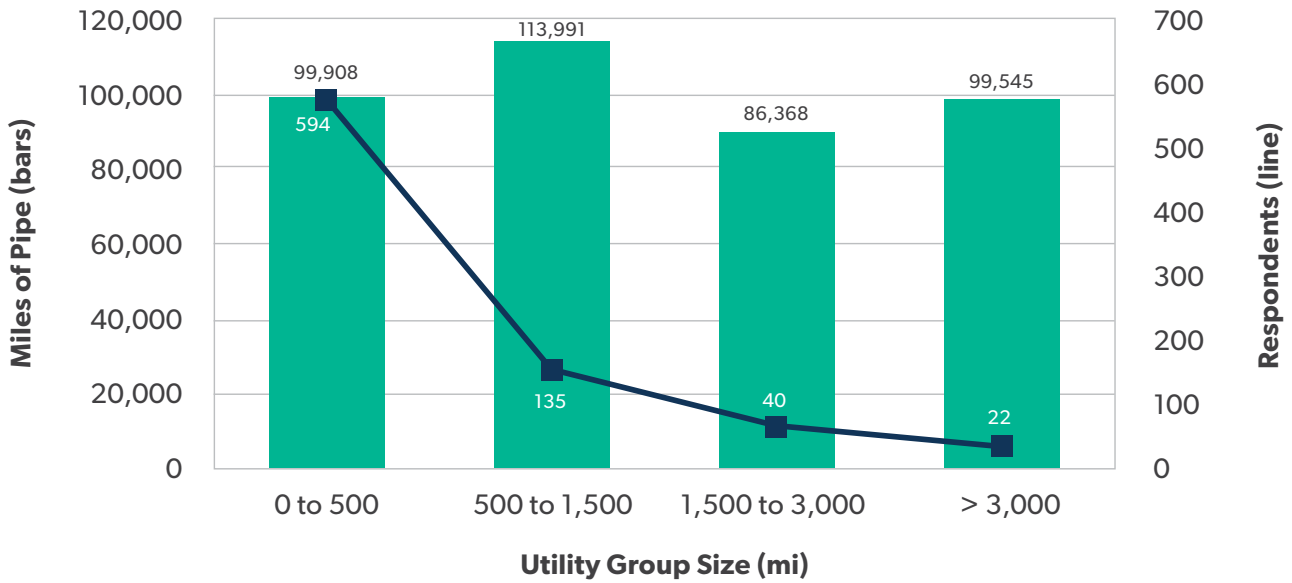
**FIGURE 8: TOTAL MILES OF PIPE IN EACH SIZE GROUP AND THE NUMBER OF RESPONDENTS (BASIC SURVEY)**

Utilities have been grouped into four categories in this report based on miles of installed water mains as shown in Table 2. Figure 8 shows the distribution of total miles of pipe from the basic survey based on these categories (bar graph with left axis) along with the number of respondents (line graph with right axis). The total miles of pipe are evenly distributed in terms of pipe length within each utility size (from small to very large). Figure 9 shows how the proportion of small utilities in the study have increased from 68% in 2018 to 75% in 2023. The number of utilities reporting from all four size groups increased significantly between 2018 and 2023.

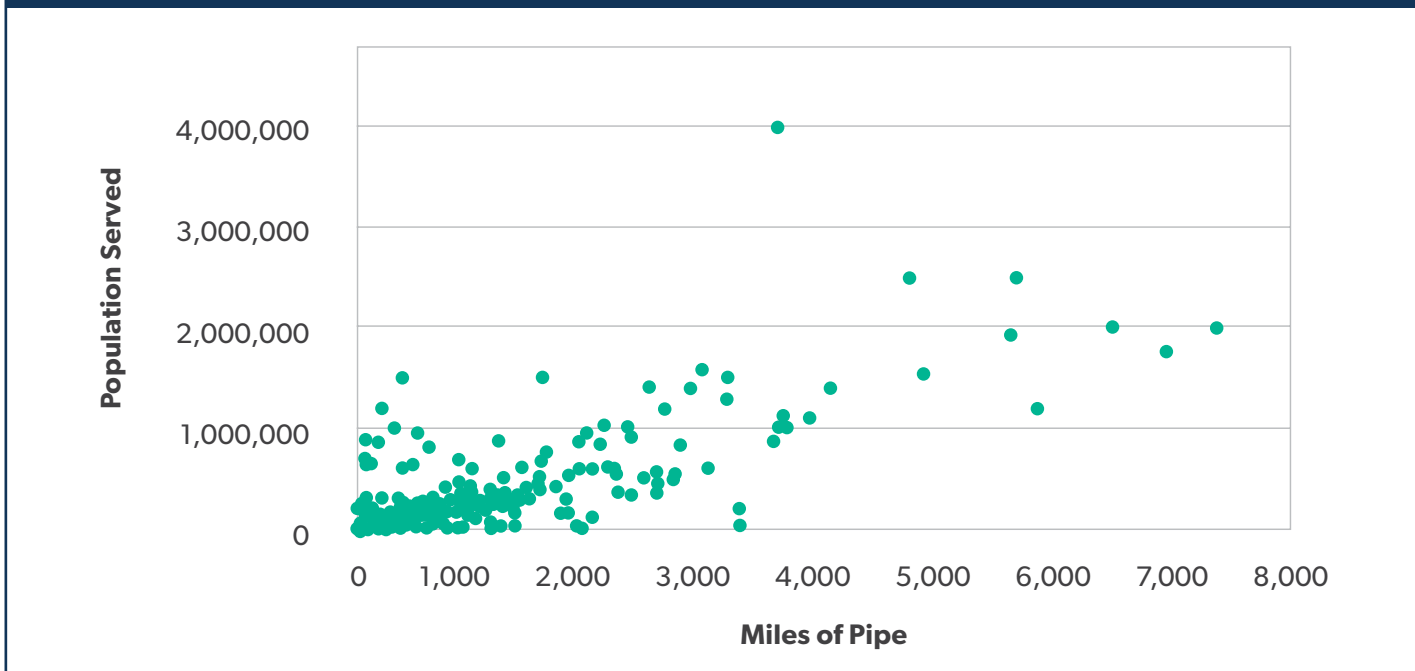
FIGURE 10: POPULATION SERVED RELATIVE TO TOTAL MILES OF PIPE (BASIC SURVEY)

Figure 10 illustrates the distribution of population served by the utilities participating in the basic survey against the number of miles of water mains. Figure 11 shows average population served per mile of pipe for each region, producing an overall average of 287 people served per mile. The 2018 survey reported this value as 308 while the 2012 survey reported 264 people served per mile. Utilities that provided transmission pipe data exclusively were not included (typically wholesale water providers). Water systems with a higher density of people served per mile have an increased consequence of failure and may require a higher level of asset oversight.

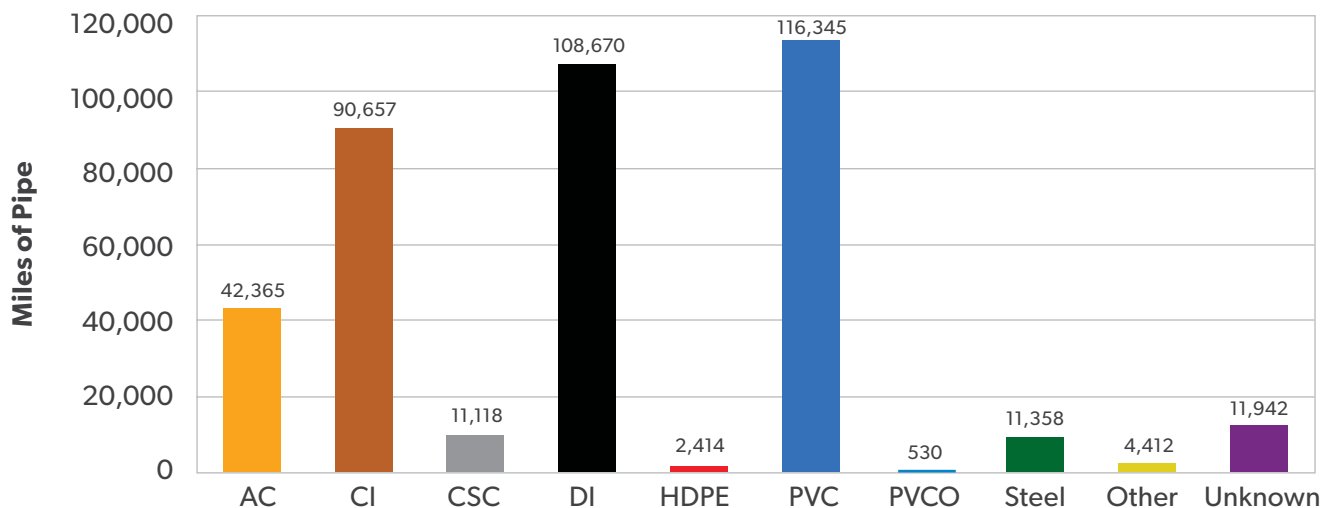
**FIGURE 12: MILES OF PIPE BY MATERIAL TYPE (BASIC SURVEY)**

Figure 12 illustrates the length of pipe by material type reported in the basic survey. The “Other” category in Figure 12 includes materials such as wood and fiberglass. The “Unknown” category includes reported mileage for unidentified pipe material. When only small amounts of pipe mileage are available for analysis, calculated break rates become unreliable. There was very little high density polyethylene (HDPE) pipe and molecularly oriented polyvinyl chloride (PVCO) reported in this survey, so these two materials along with the materials in the “Other” category were excluded from the failure rate analysis. Concrete steel cylinder (CSC) pipe was also omitted from the analysis because the data included only transmission pipe in larger diameters and did not include smaller pipe sizes.

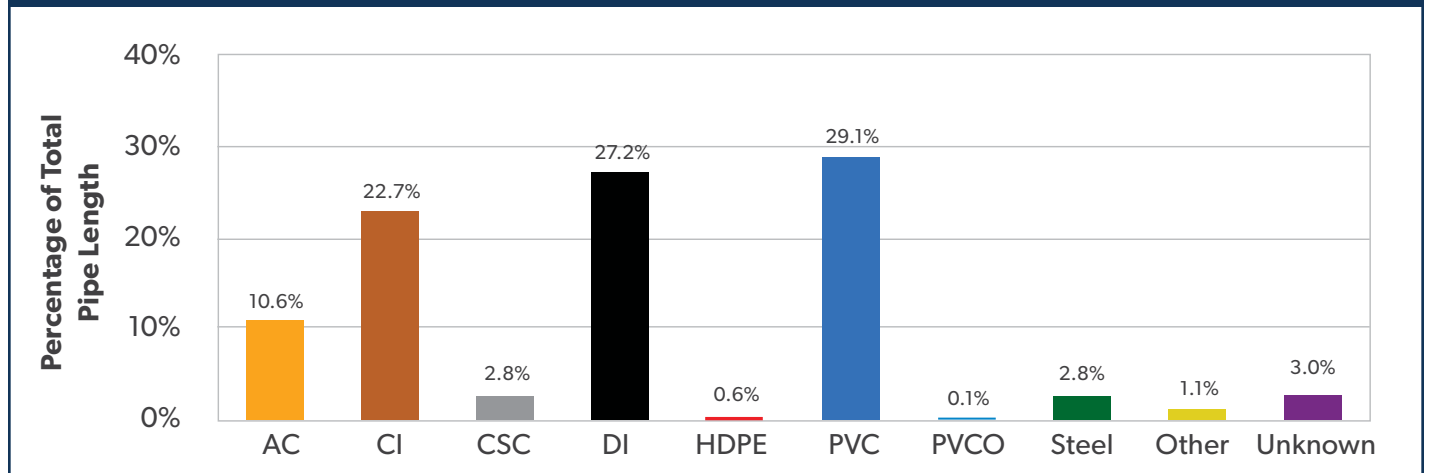
**FIGURE 13: PERCENTAGE OF PIPE LENGTH BY MATERIAL TYPES (BASIC SURVEY)**

Figure 13 illustrates the percentage of total length of water mains by pipe material. It is significant to consider that nearly 90% of the water mains reported are made from cast iron (CI), asbestos cement (AC), ductile iron (DI), and polyvinyl chloride (PVC) materials. This is consistent with earlier USU studies (Folkman, 2012; 2018). The EPA provides a summary of the timelines of when these materials have been in use: *The majority of distribution piping installed in the United States, beginning in the late 1800's up until the late 1960's, was manufactured from cast iron... referred to today as "pit" cast iron pipe. ...In 1920, the process of centrifugally casting pipe in a sand mold was introduced... referred to as "spun" or "centrifugally" cast iron pipe (which was commonly installed until the 1970's). Asbestos cement became commercially available in the 1930's and was commonly installed during the 1950's and 1960's. Following this was the introduction of ductile iron pipe in the late 1960's. Shortly after the introduction of ductile iron, the use of ... polyvinyl chloride (PVC) ... in this country began to emerge in the 1970's (EPA, 2002).*

As shown in Figure 13, the percentages for the installed CI and AC pipe in 2023 are 22.7% and 10.6%, respectively. Figure 13 also illustrates that PVC has the highest percentage of all pipe materials at 29.1%, with DI pipe at 27.2%. As shown in Figure 14, in 2018 CI and AC pipe accounted for 28.4% and 12.7% of all pipe miles, respectively. The combined inventory for these two materials in 2018 was 41.1%, and 33.3% in 2023. This represents a reduction of 7.8% in the reported pipe inventory. During the same 5-year period, reported PVC pipe length increased by 7.0% and DI remained approximately the same. It is noteworthy that the reduction in CI and AC is similar to the increase in the installed length of PVC pipe.

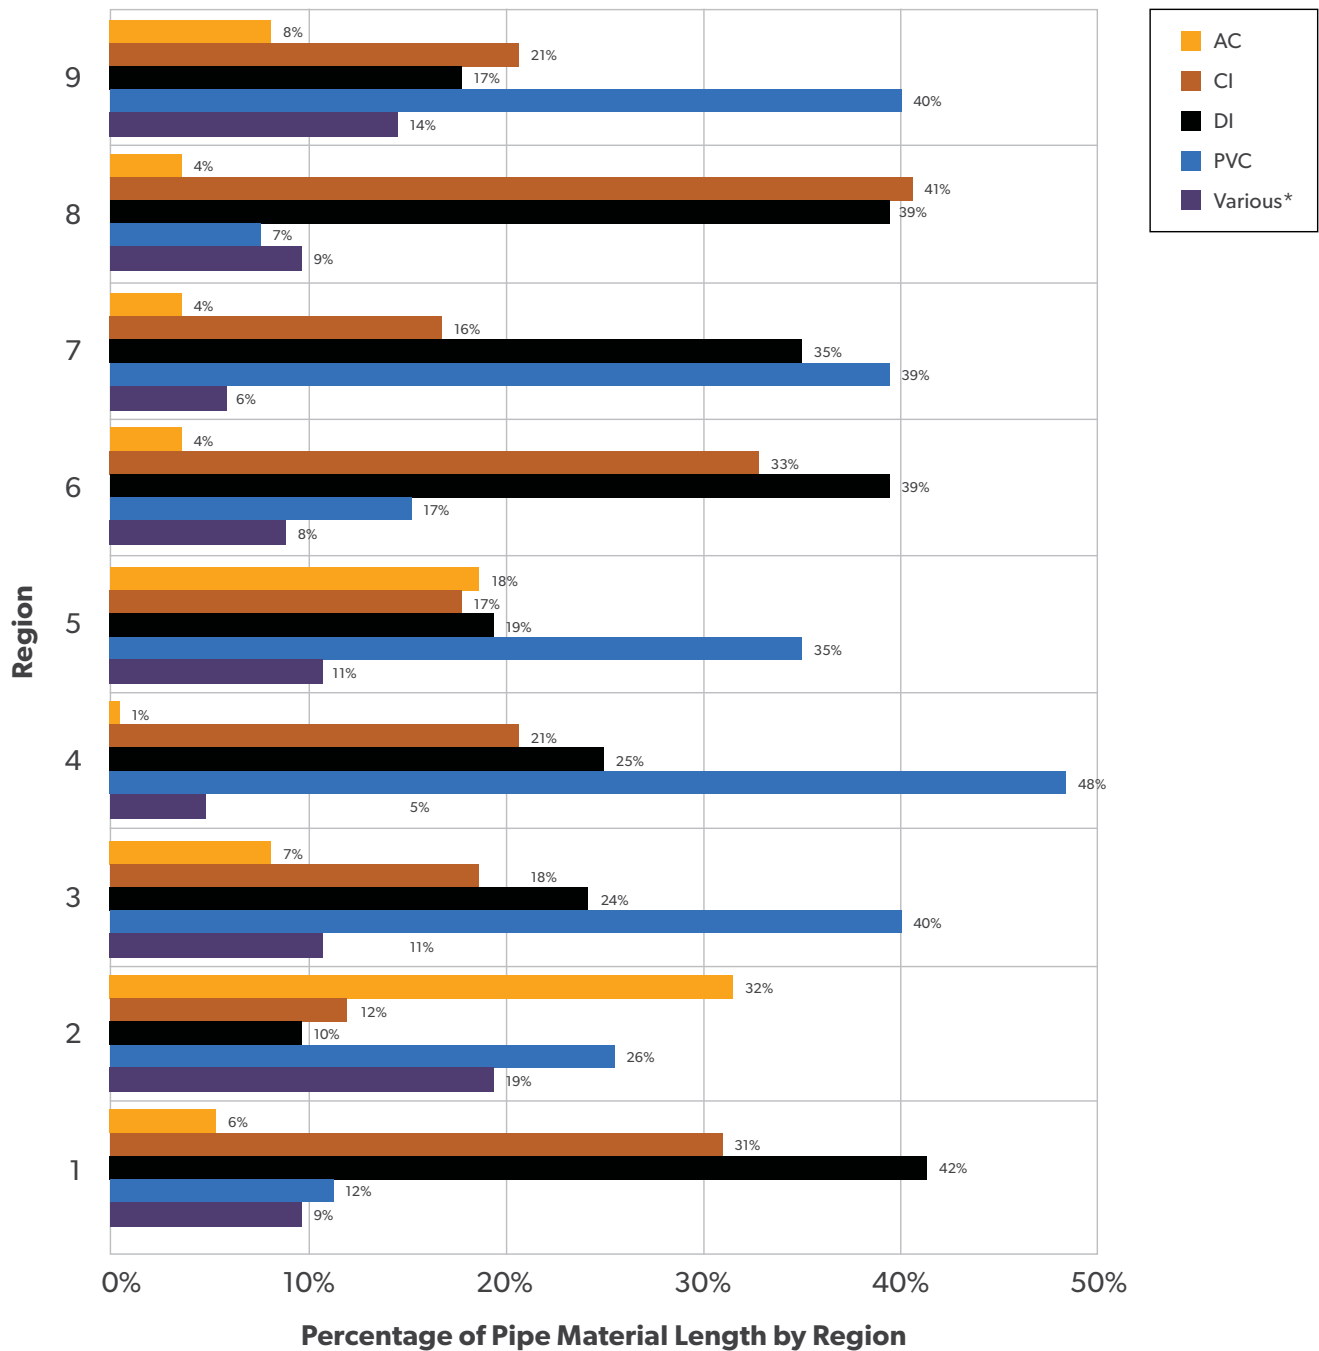
**FIGURE 16: PIPE MATERIAL USAGE AS A PERCENTAGE OF TOTAL LENGTH BY REGION (BASIC SURVEY)**

Figure 15 illustrates again the regions represented in the report. Figure 16 shows the regional distribution of pipe material usage as a percentage of the total length in that region. It is interesting to note the significant differences in regional pipe material utilization. CI is predominant in Region 8, while DI pipe is predominant in Regions 1 and 6. PVC has a leading role in Regions 3, 4, 5, 7 and 9. AC pipe has a significant presence in Region 2.

\*The "Various" category combines all pipe materials that are at 3% and below of the total pipe length, which includes: CSC (2.8%), HDPE (0.6%), PVC0 (0.1%), Steel (2.8%), Other (1.1%), and Unknown (3.0%).

Material usage varies significantly across geographic regions, suggesting that selection of pipe materials is often based on preference. For example, the upper northwest and eastern half of the US (Regions 1, 6, and 8 in Figure 3) is predominantly comprised of either cast iron or ductile iron pipe, while PVC pipe is the most used in Regions 3, 4, 5, 7, and 9. The most common pipe material in Region 2 is asbestos cement.

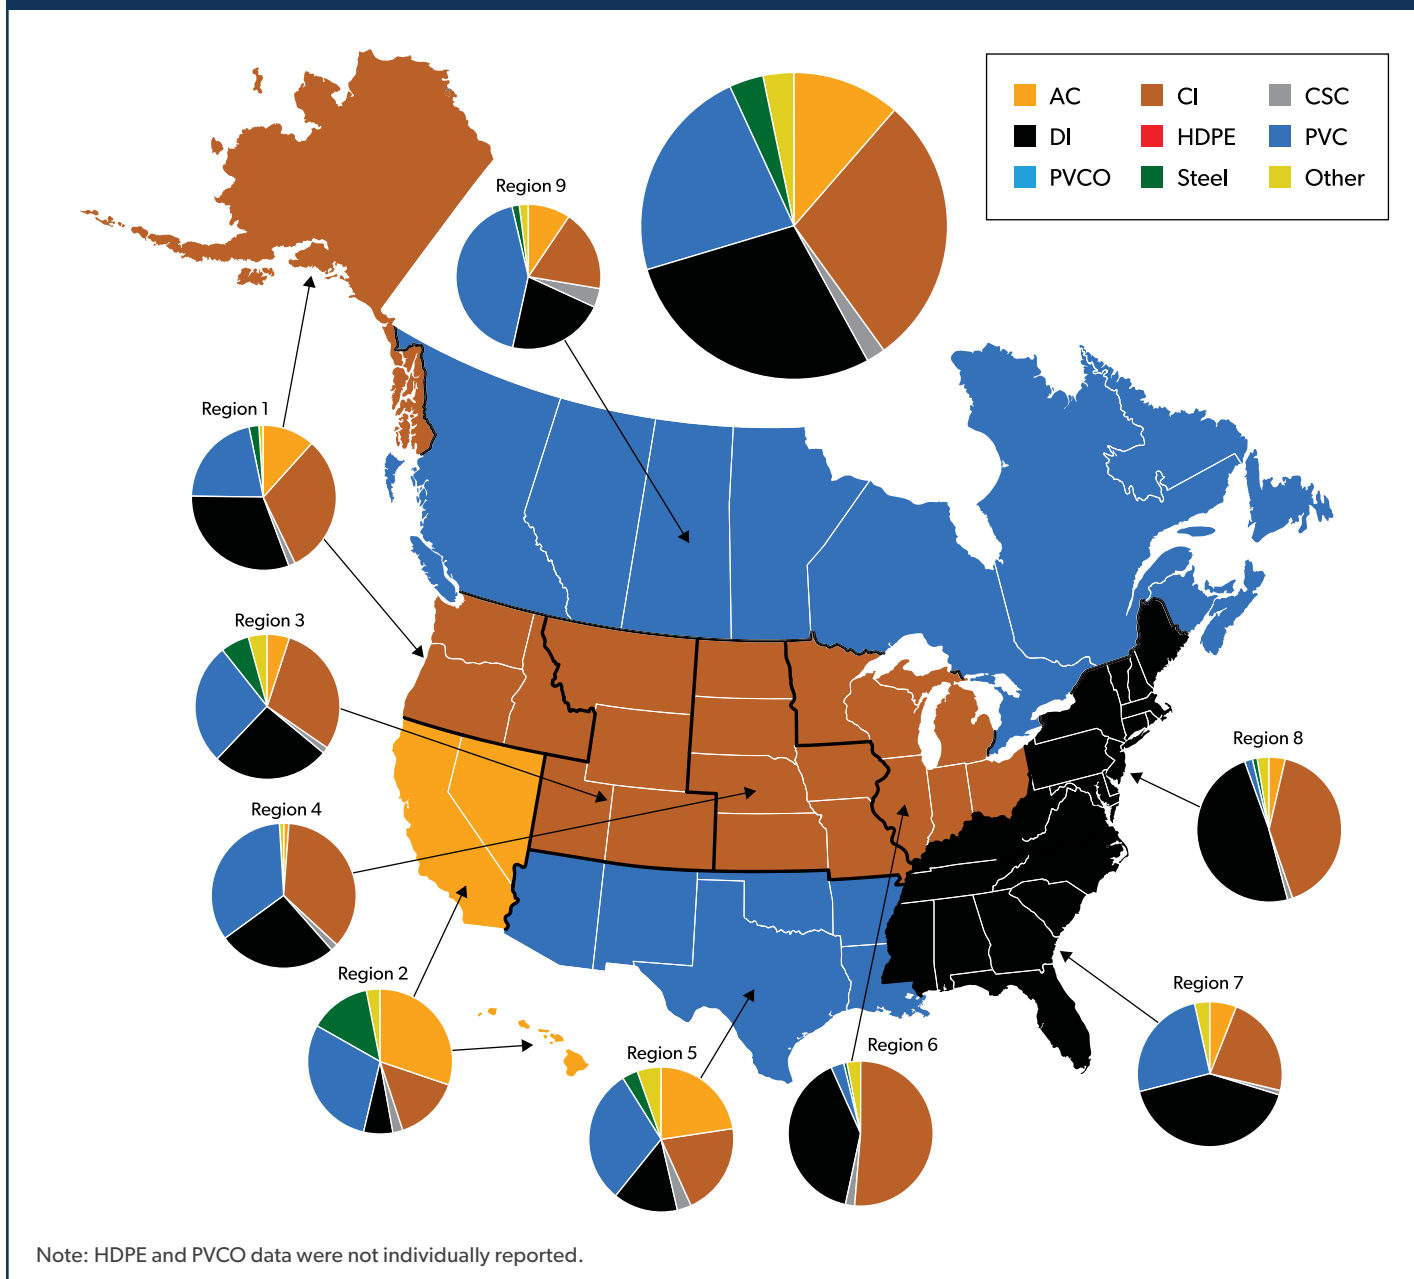
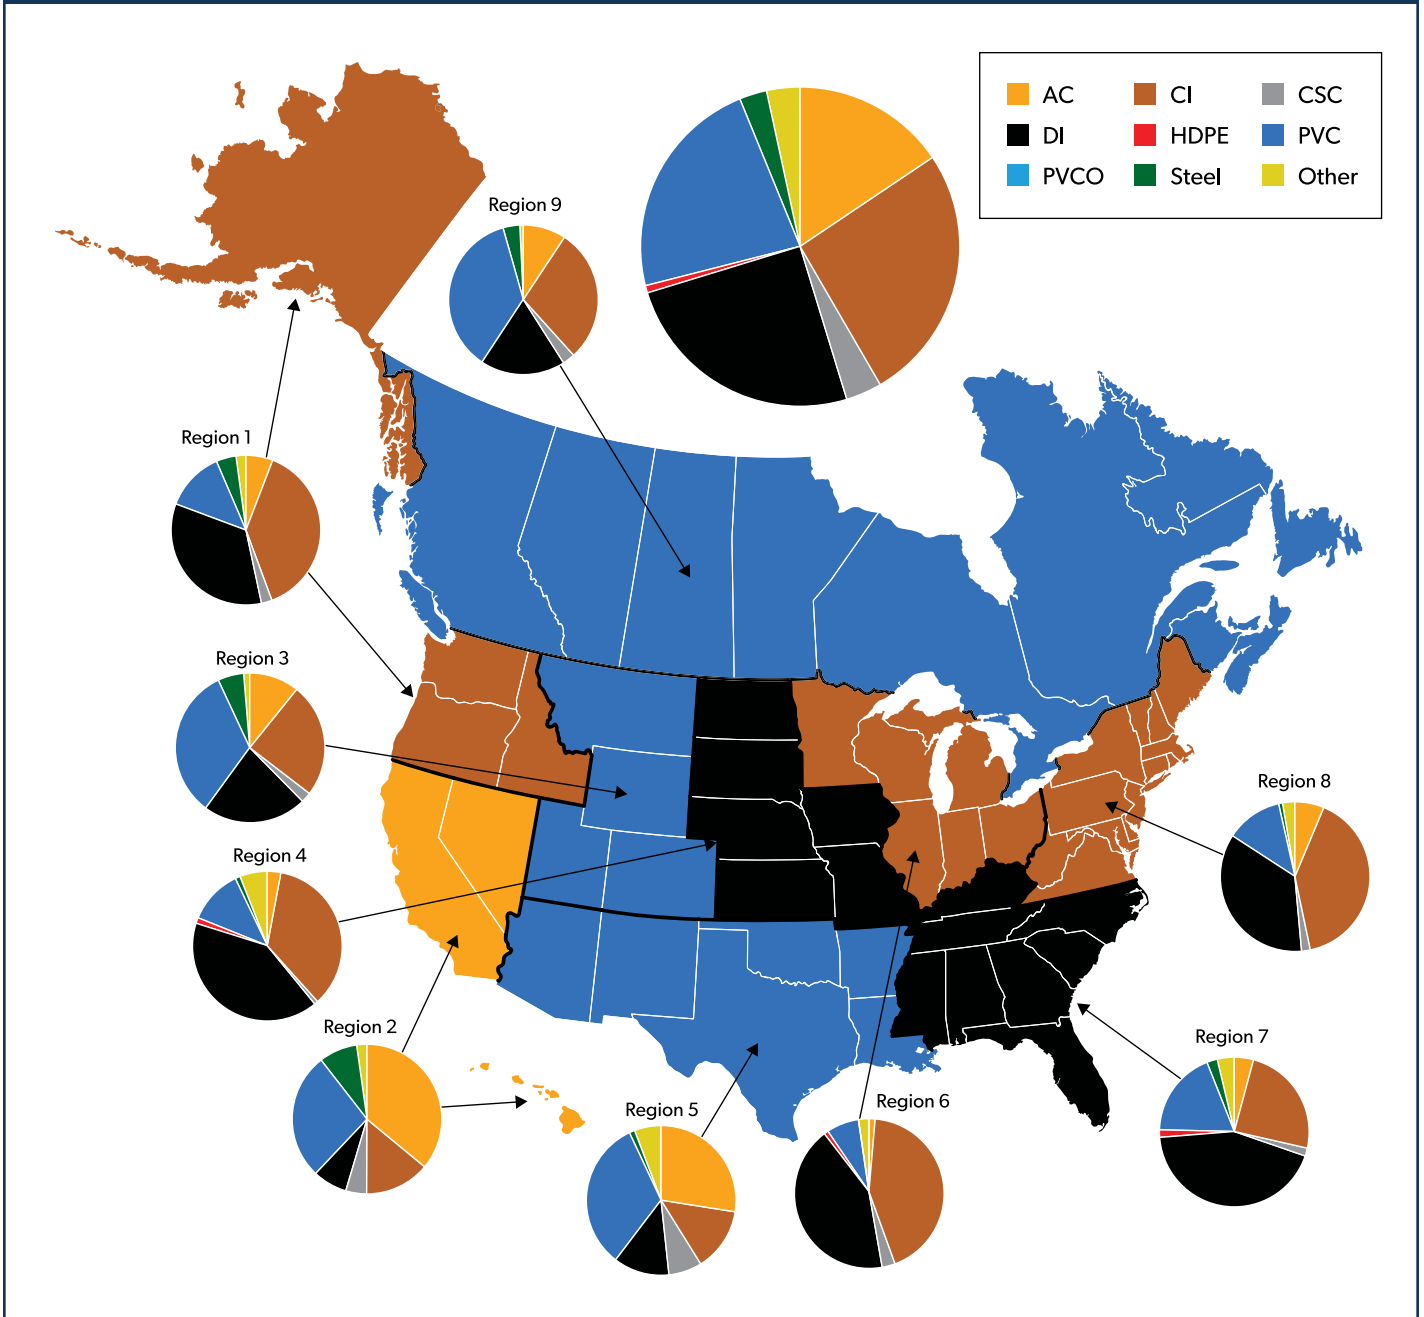
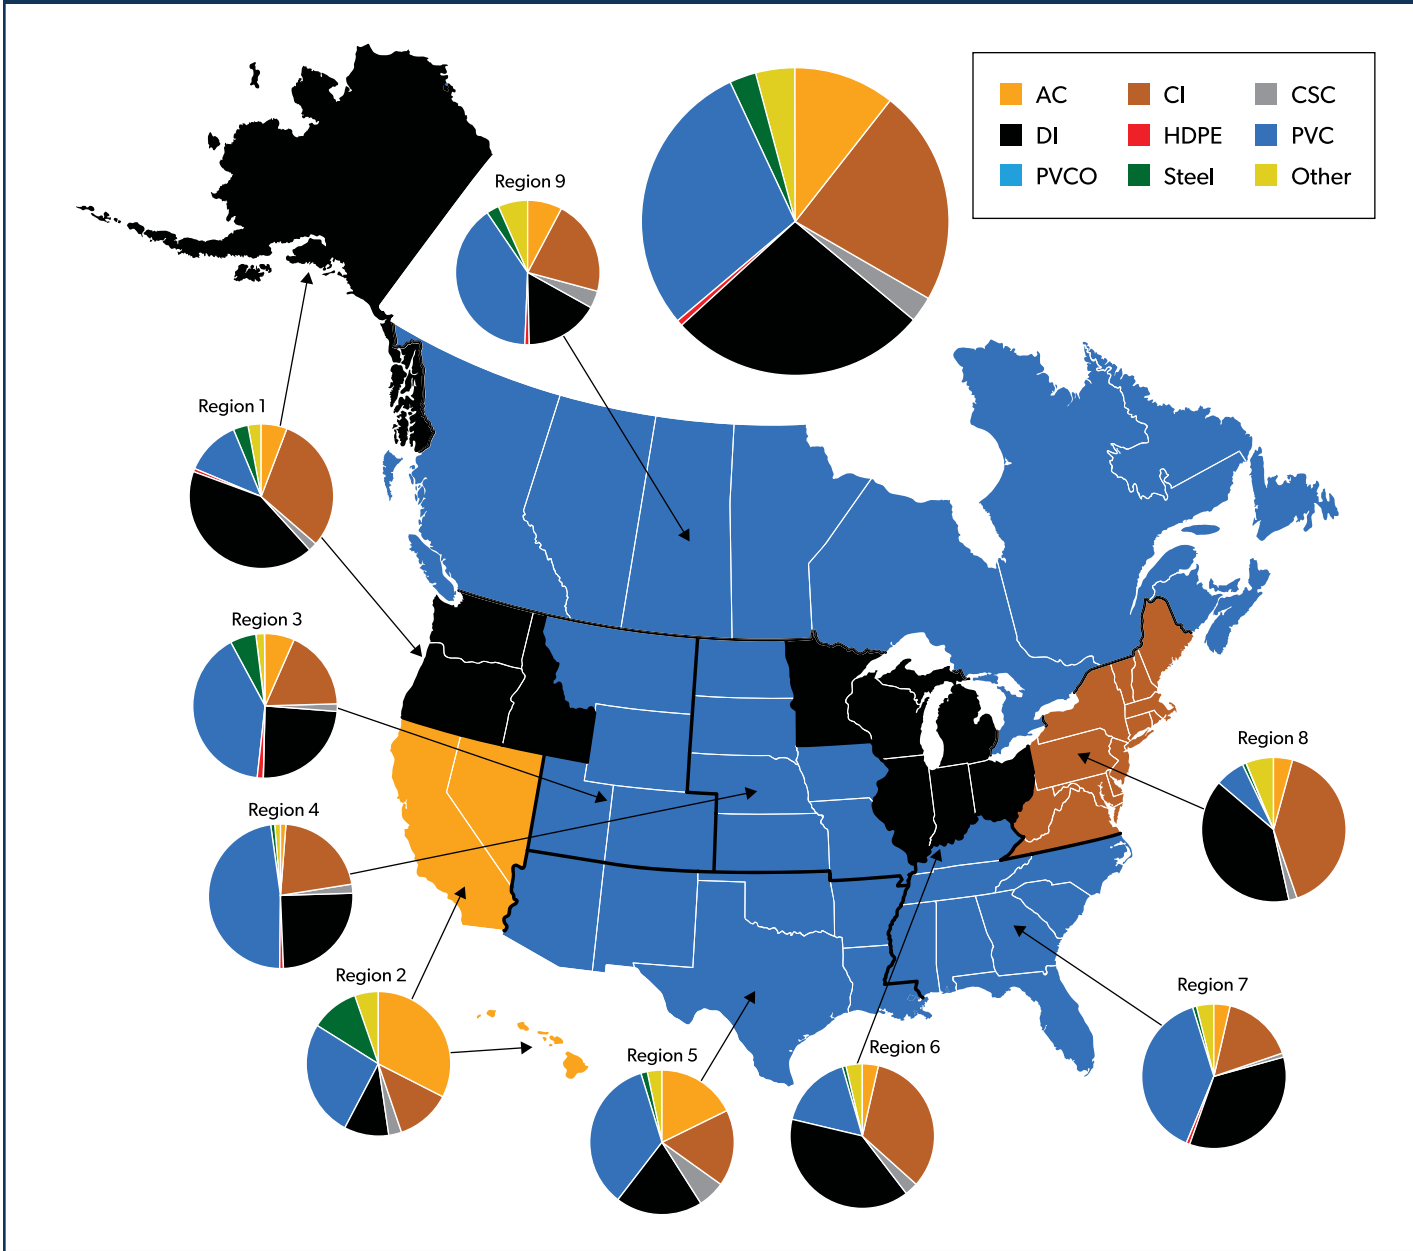
Figures 17, 18, and 19 display the use of pipe materials as reported in the 2012, 2018, and 2023 USU studies, respectively. Each region on the map is colored according to the predominant pipe material installed there. Comparing these figures provide an understanding of the significant pipe usage trends occurring in the US and Canada in the last decade, which are as follows:

- ▶ Regions 1 and 6 are trending toward DI.
- ▶ Regions 3, 4 and 7 are shifting towards PVC.
- ▶ PVC remains predominant in Regions 5 and 9.
- ▶ CI and DI remain the most common pipe materials in Region 8.
- ▶ AC is still the most common pipe material in Region 2.
- ▶ CI has been replaced by other materials in Regions 1, 3, 4 and 6.

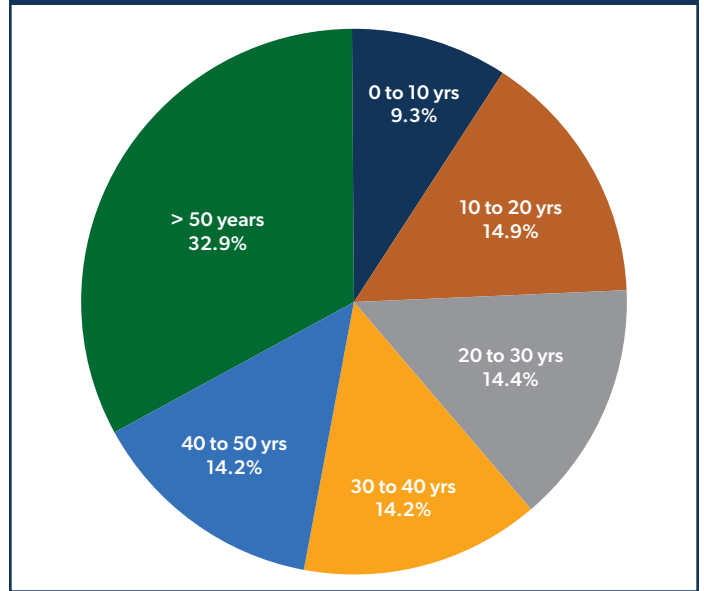
**FIGURE 20: PIPE AGE DISTRIBUTION FOR ALL MATERIAL TYPES (DETAILED SURVEY)**

**PIPE AGE.** The detailed survey asked respondents to provide the distribution of installed pipe by material type and age, grouped as follows: 0 to 10 years, 10 to 20 years, 20 to 30 years, 30 to 40 years, 40 to 50 years, and over 50 years. Figure 20 shows the age distribution for all pipe materials combined, indicating that 33% of all installed pipes are over 50 years old.

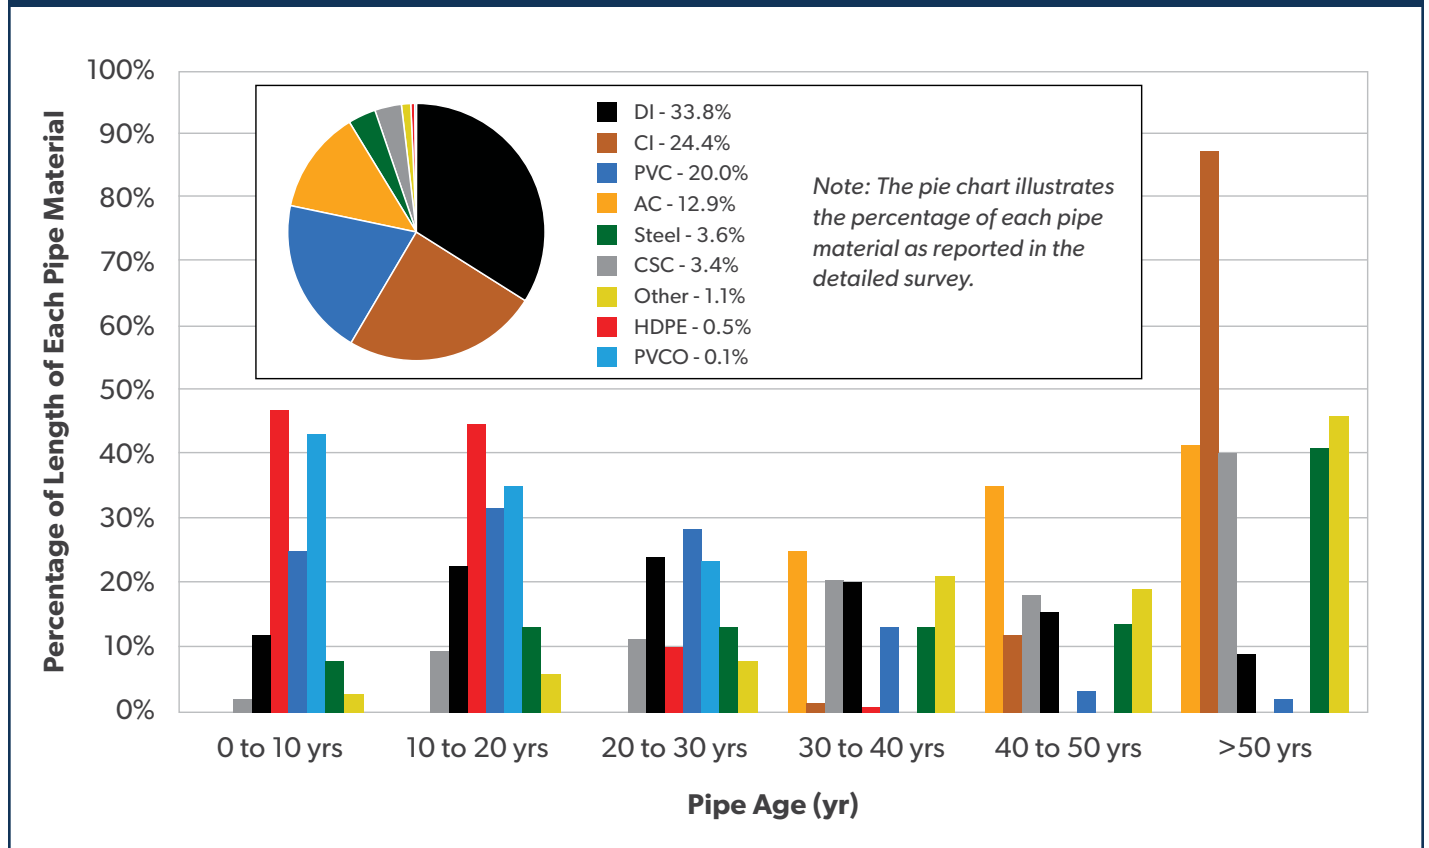
**FIGURE 21: PIPE AGE DISTRIBUTION FOR EACH MATERIAL TYPE (DETAILED SURVEY)**

The bar graph in Figure 21 illustrates the age distribution for each pipe material by length. For example, survey results indicate that the majority of CI pipes are over 40 years old with 11% in the 40- to 50-year category and 86% over 50 years of age. Conversely, HDPE and PVCO are relatively new pipe materials with most being installed in the last 20 years.

The pie chart in Figure 21 summarizes the significance of each pipe material in terms of reported total pipe mileage in the detailed survey. For example, DI is at 33.8%, CI shows 24.4%, while HDPE represents 0.5%, and PVCO is 0.1% of all pipe miles.

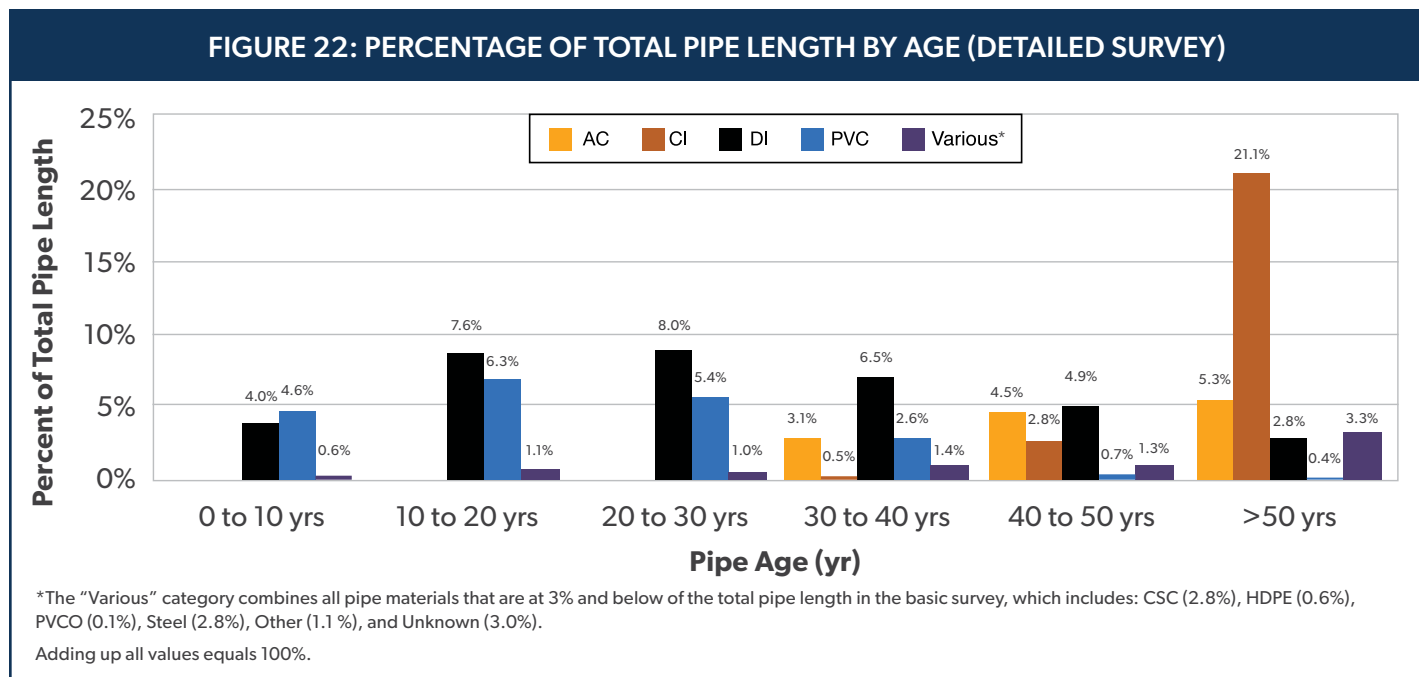
Figure 22 shows the age distribution as a percentage of the total length of all pipe materials from the detailed survey. For example, CI older than 50 years is 21% of all installed pipe. For ages between 0 to 10 years, DI and PVC both have about 4 to 5% of the total installed length. This means that the most common pipe materials installed over the last 10 years are DI and PVC.

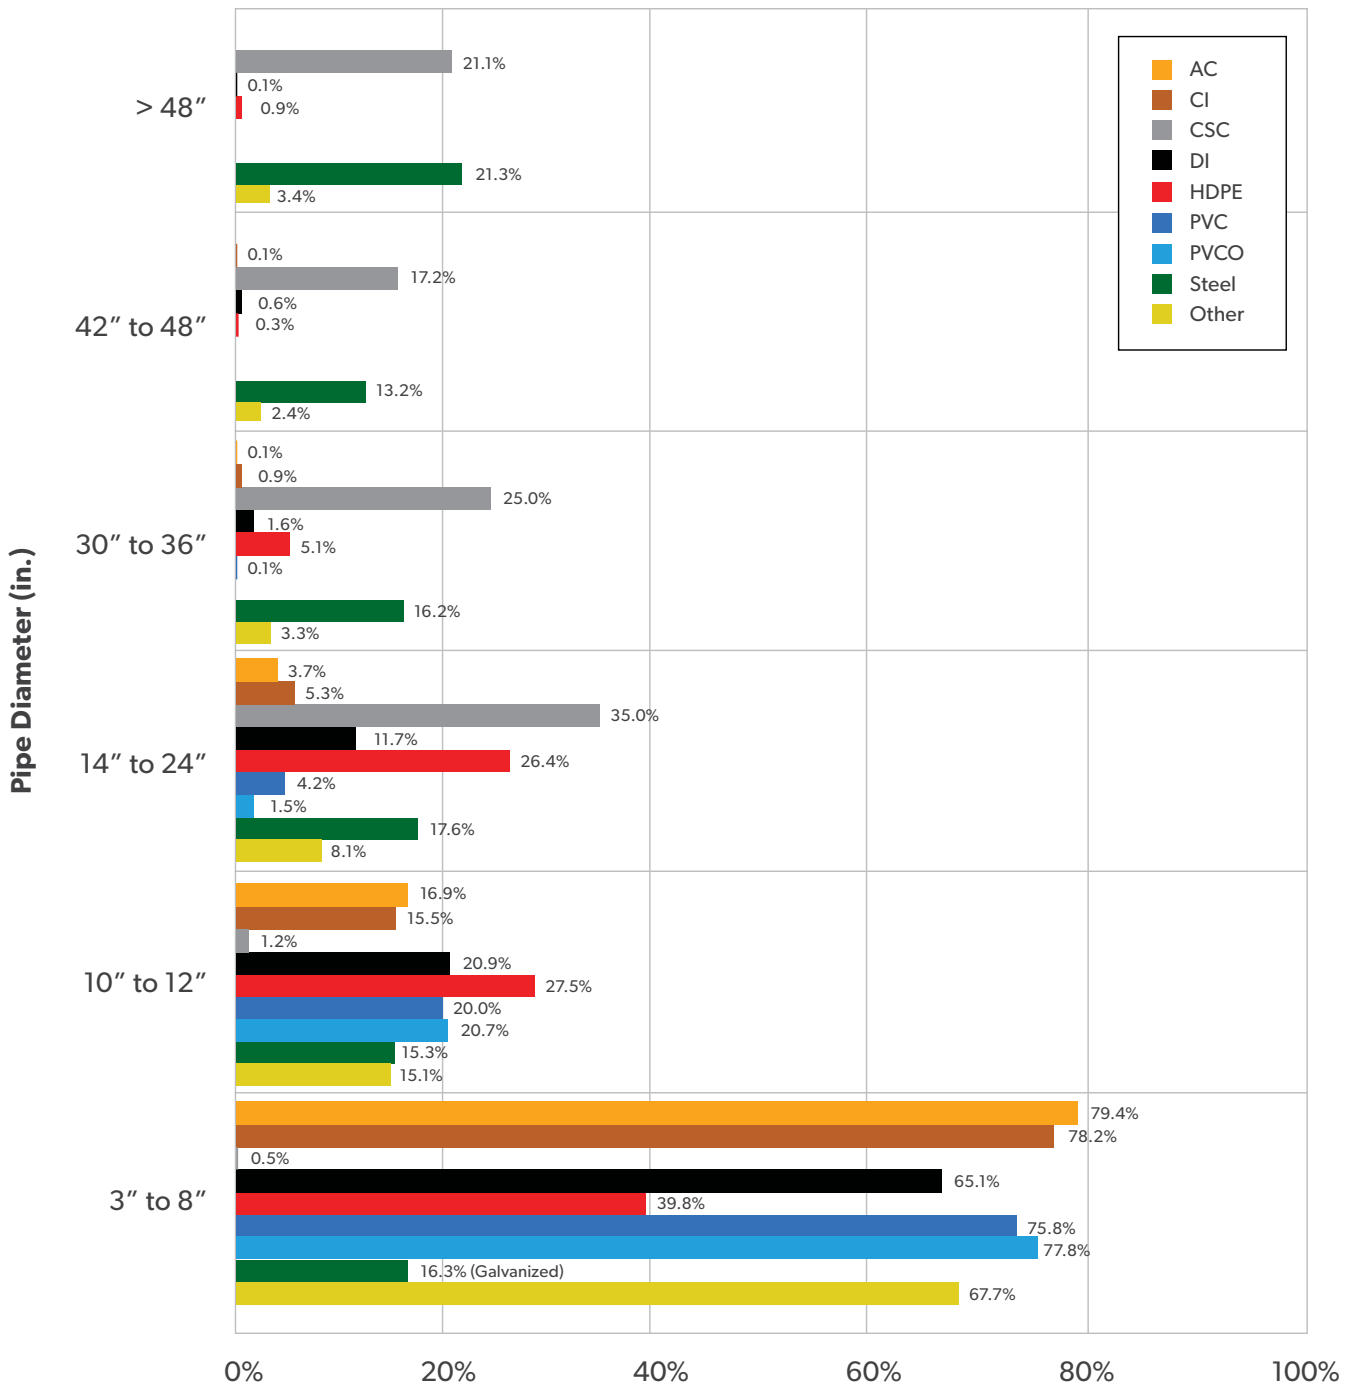
**FIGURE 24: PIPE DIAMETER DISTRIBUTION BY MATERIAL TYPE (DETAILED SURVEY)**

Figure 24 illustrates the diameter distribution for each material type as reported from the detailed survey. The figure shows that most large diameter pipes (14-inch and larger) are predominantly steel and CSC, with each material having more than 21% of their length in sizes larger than 48-inch. More than 98% of the CSC pipe was in sizes 14-inch and larger. The figure also shows that over 75% of all AC, CI, PVC and PVCO pipe, respectively, is 8-inch or smaller.
