**New Report Assists Water Utilities with Infrastructure Asset Management, Pipe Repair, and Replacement**

December 2023

A Resource to Support Asset Management,  
Pipeline Renewal, and Replacement

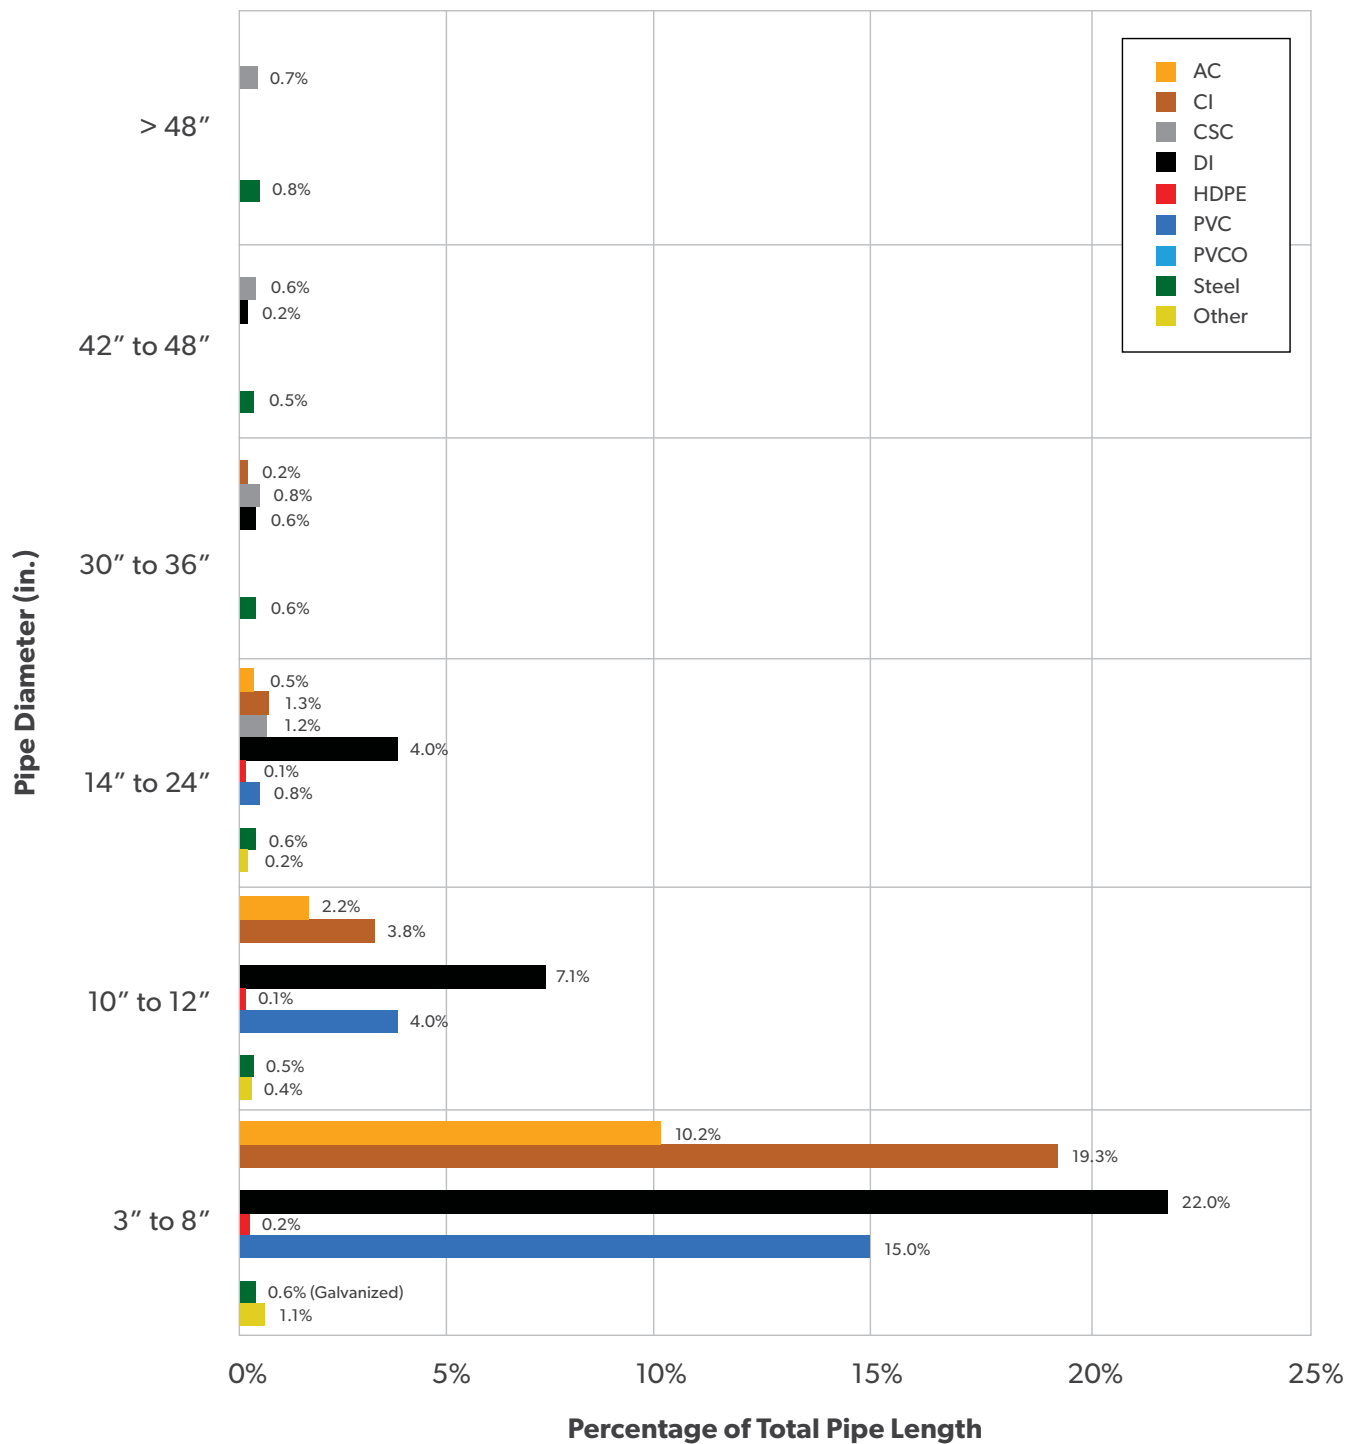
**FIGURE 25: PERCENTAGE OF TOTAL PIPE LENGTH BY DIAMETER AND MATERIAL TYPE (DETAILED SURVEY)**

Figure 25 illustrates for each pipe material the percent of total length by material type and diameter. It shows that DI and PVC pipe from 3 to 8 inches in diameter represent over 22% and 15%, respectively, of all installed pipe as reported from the detailed survey. Steel pipe less than 14-inch in diameter is most likely galvanized steel, while larger diameter steel is typically carbon steel. As discussed previously, the pipe mileage data from the detailed survey differs from the data collected in the basic survey due to the difference in sample size.

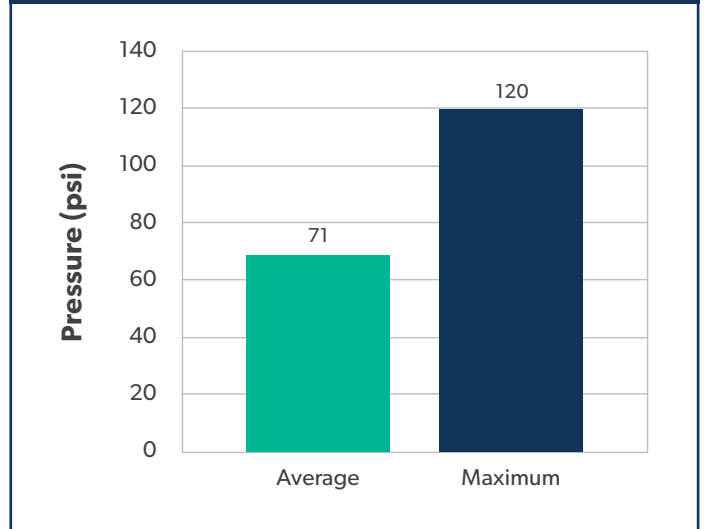
**FIGURE 26: AVERAGE AND MAXIMUM WATER SUPPLY PRESSURES (BASIC SURVEY)**

The basic survey asked for the average and maximum water supply pressures. As shown in Figure 26, the mean average and maximum water supply pressures are 71 and 120 psi, respectively. In the 2018 survey, the mean and maximum pressures were 69 and 119 psi, respectively, which is consistent with this survey result.

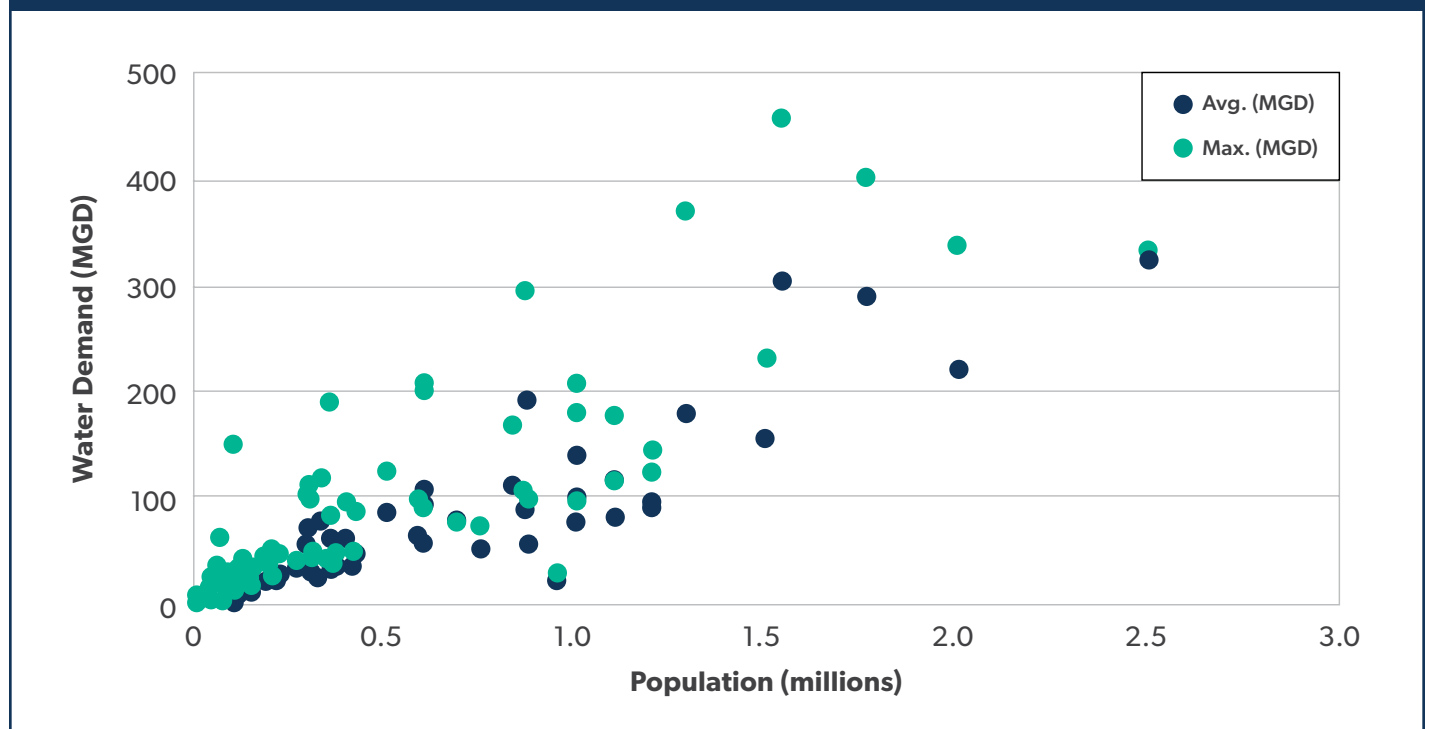
**FIGURE 27: AVERAGE AND MAXIMUM WATER DEMAND BY POPULATION (DETAILED SURVEY)**

The detailed survey also asked for the average and maximum daily water demand. The reported values were divided by the population served and averaged. To prevent potential overcounting, utilities that were only transmission systems were excluded since they are typically wholesale water providers and do not service end users. The average water demand is 143 gallons per day for each person. The maximum water demand is 247 gallons per day for each person. The values for 2018 were 137 and 251, respectively. Figure 27 shows each utility's average and maximum demand values in units of MGD (millions of gallons per day) versus the population served in millions.

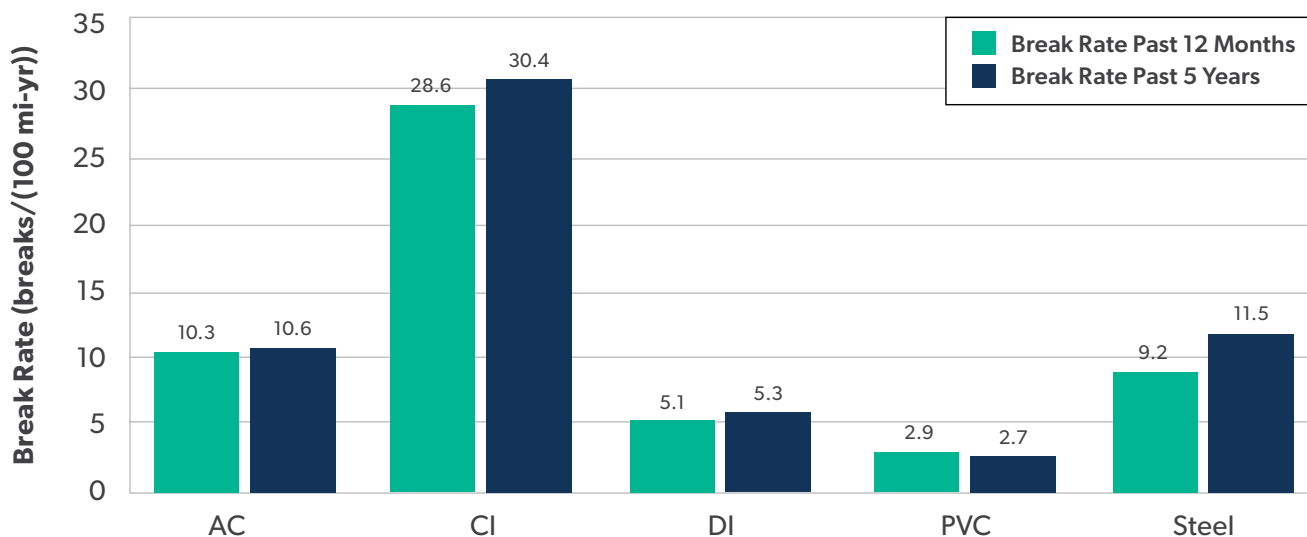
**FIGURE 29: BREAK RATES BY PIPE MATERIAL FOR A 12-MONTH AND 5-YEAR PERIOD (BASIC SURVEY)**

Figure 28 illustrates the failure rates by pipe material for the 12-month period used in the current study. PVC has the lowest break rate of the materials shown, while CI has the highest. In both 2012 and 2018 USU surveys, PVC also had the lowest break rate. Figure 29 shows the failure rates over 12-month and 5-year periods. In both cases, the relative break rates remain the same for all materials, and therefore, it is anticipated that future break rates will continue to remain consistent. Pipe materials that did not have a significant presence in the survey results (in terms of pipe miles represented) are not included in subsequent tables and figures. This decision was made to avoid calculating unrealistic break rates due to low reported miles of pipe.

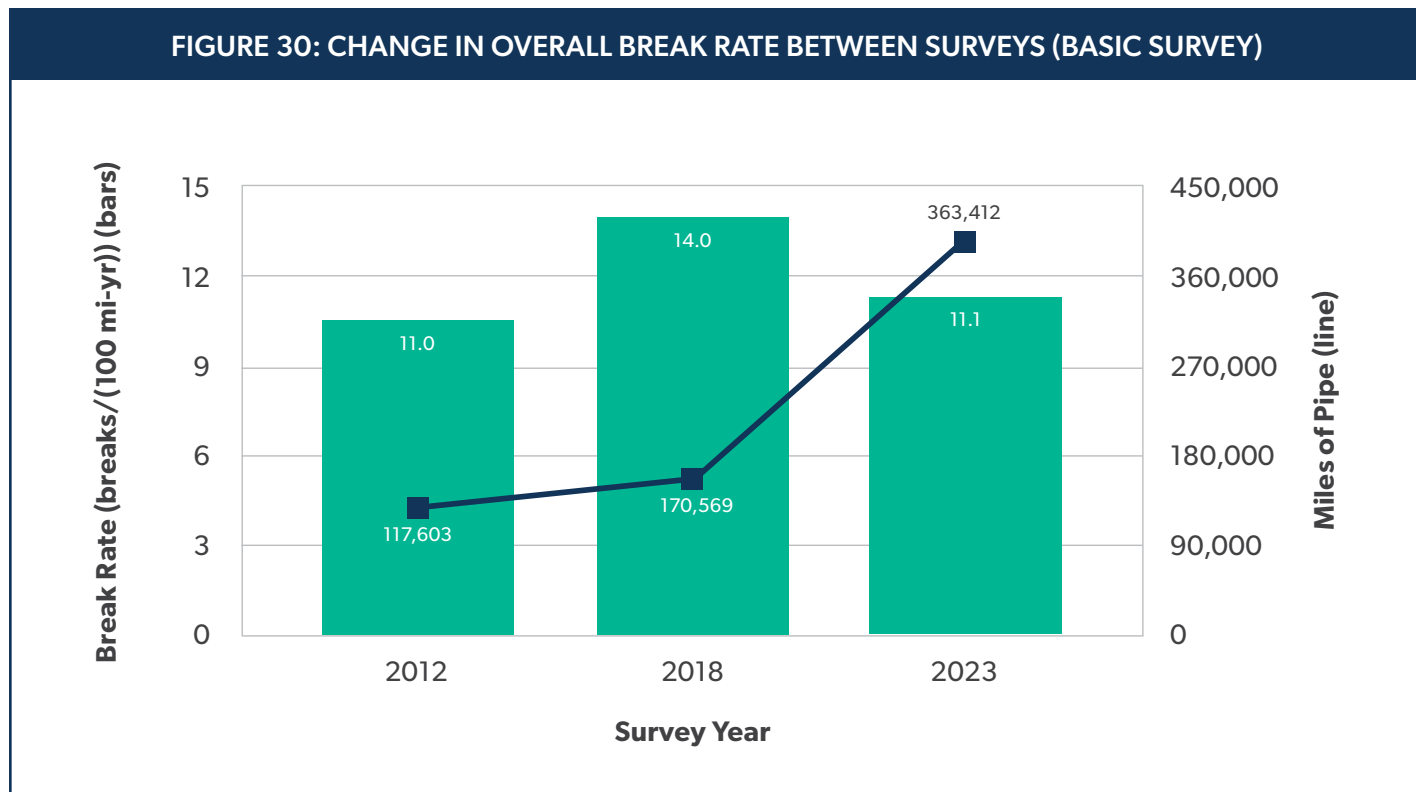
Figure 30 illustrates the overall reported break rates from this survey and the two previous reports (Folkman, 2012; 2018). It is apparent from the figure that the current survey represents a significant number of pipe miles. Even with this large sample size, the overall break rates are relatively consistent with only a slight reduction in failure rates in the last five years. This decrease may indicate that more utilities are applying asset management techniques and replacing pipe with the highest break frequency.

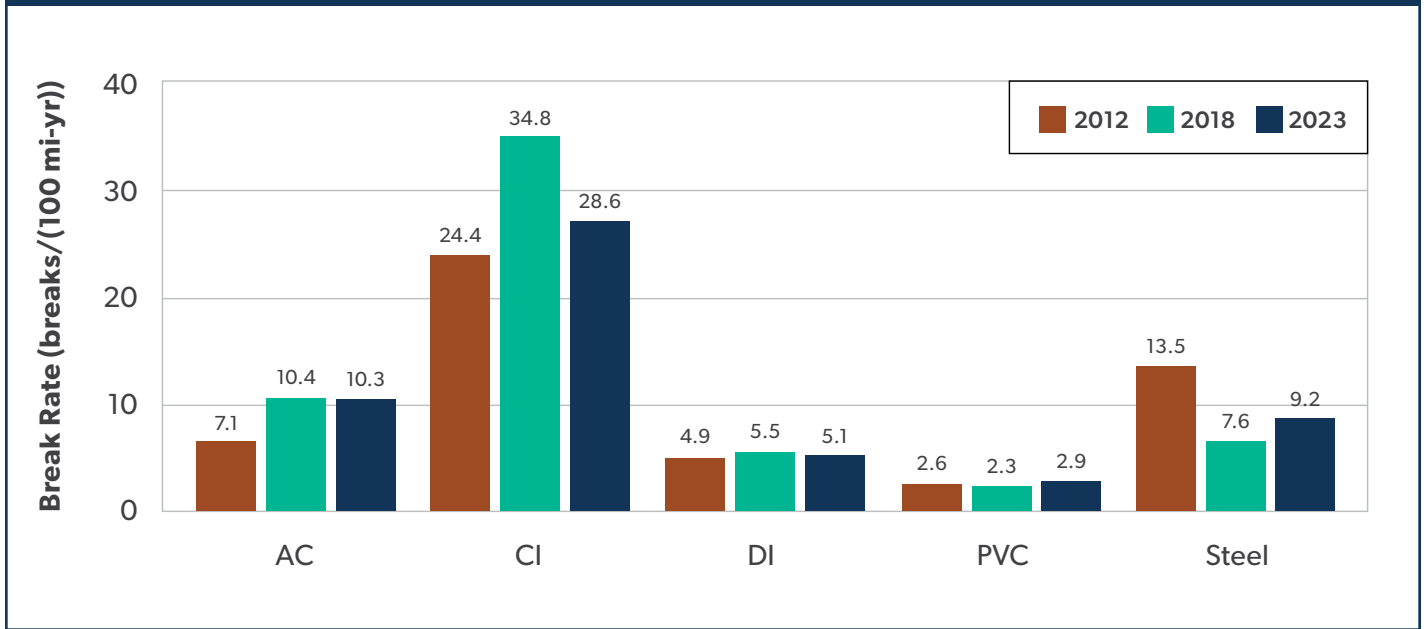
**FIGURE 31: COMPARISON OF BREAK RATES FROM THE 2012, 2018, AND 2023 BASIC SURVEYS**

Figure 31 compares the break rates of common water pipe materials from the 2012, 2018, and 2023 USU surveys. The consistent break rates across the three studies help to validate the accuracy of the data. Small variations can be assumed to be data scatter. Since about 90% of installed pipe consists of AC, CI, DI, and PVC, the break rates for these materials are the most accurate, which avoids inaccurate calculations for pipe materials with low reported mileage. Figure 31 shows an insignificant break rate change over time for PVC and DI pipe.

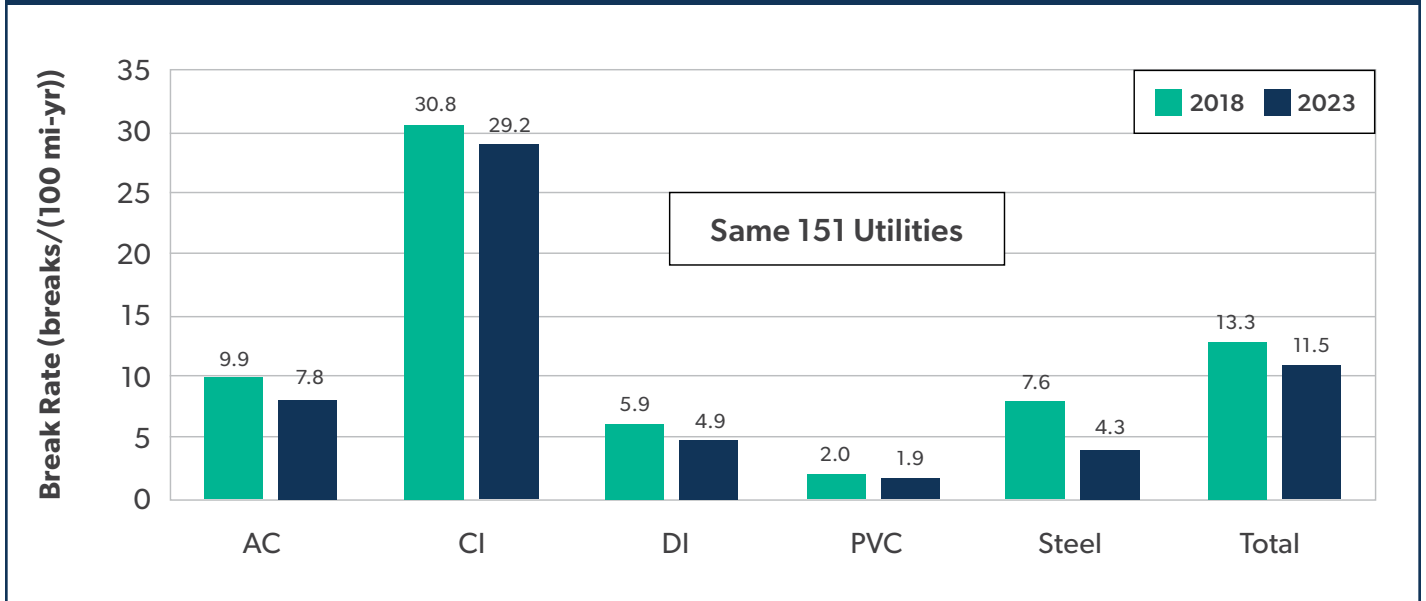
**FIGURE 32: COMPARISON OF BREAK RATES FROM THE 2018 AND 2023 BASIC SURVEYS FROM THE SAME 151 UTILITIES**

Figure 32 also confirms the accuracy and consistency of the break rate data for this study by comparing the responses from the same 151 utilities that reported break rates for both 2018 and 2023 USU studies.

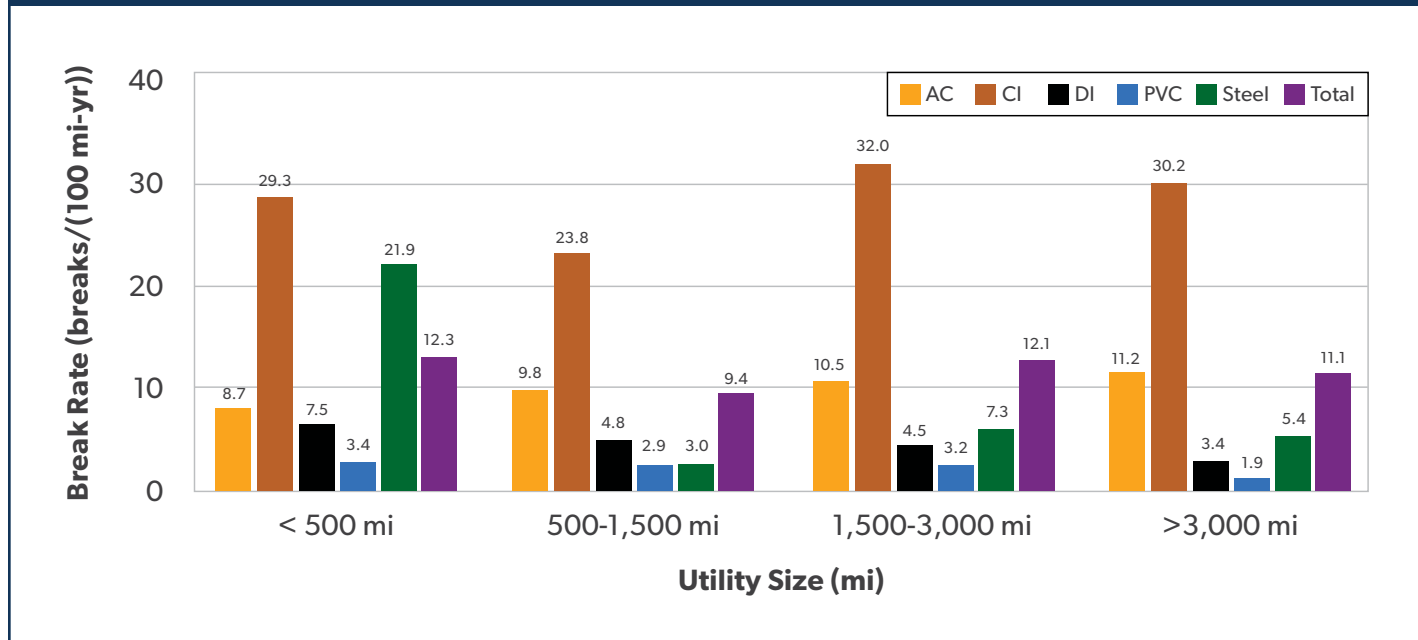
**FIGURE 33: BREAK RATES BY UTILITY SIZE FOR 12-MONTH PERIOD (BASIC SURVEY)**

Figures 33 and 34 show overall break rates by pipe material and utility size over 12-month and 5-year periods, respectively. It is noteworthy that both graphs show little correlation between break rates and utility size. Additionally, the break rates between the two figures are consistent.

Cast iron continues to have the highest break rate for utilities of all sizes. It can be assumed that the resulting high break rate for steel in small utilities is most likely due to it being galvanized steel.

- ▶ Pipe break rates as a function of utility size: Section 5.1 (Figures 33 – 34)
- ▶ Break rate comparisons by pipe diameters: Sections 5.2, 5.3 (Figure 37 and Table 6)

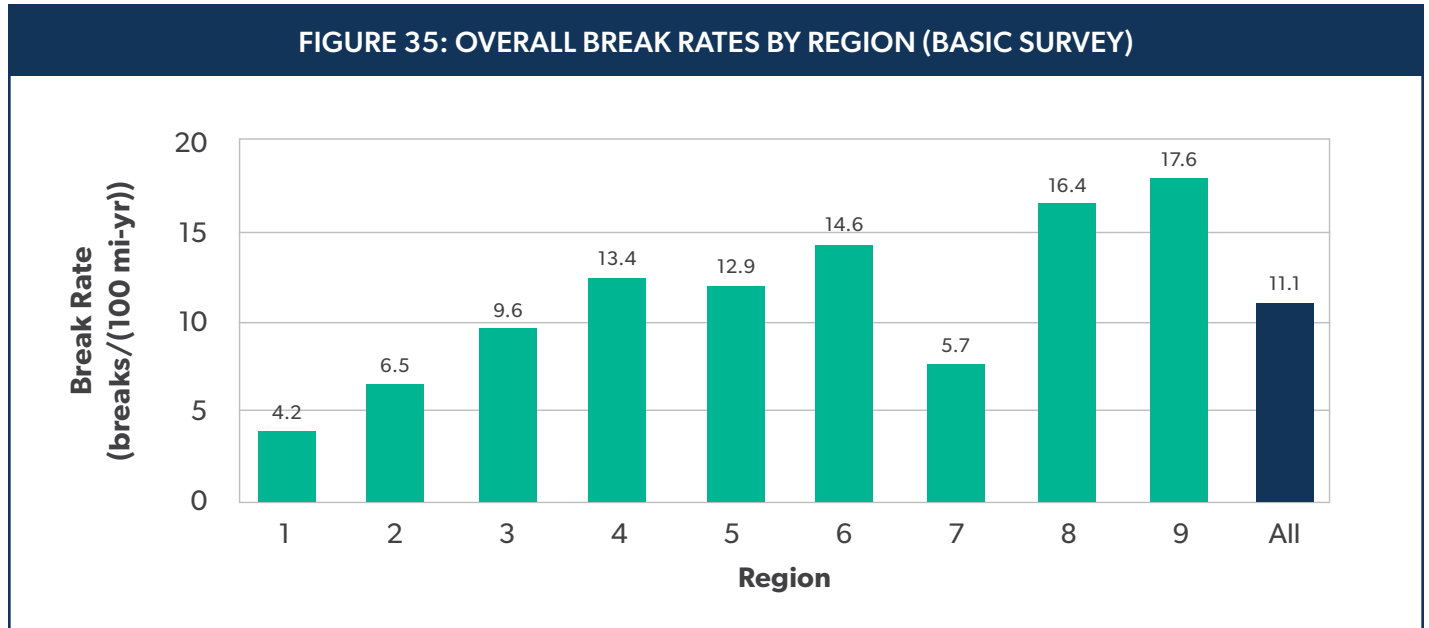
Figure 35 illustrates the reported overall break rates by region (Figure 15). In Table 1, the number of respondents for each region is summarized. Not all regions are experiencing the same failure rate. Five of the regions (4, 5, 6, 8, and 9) are above the overall average break rate.

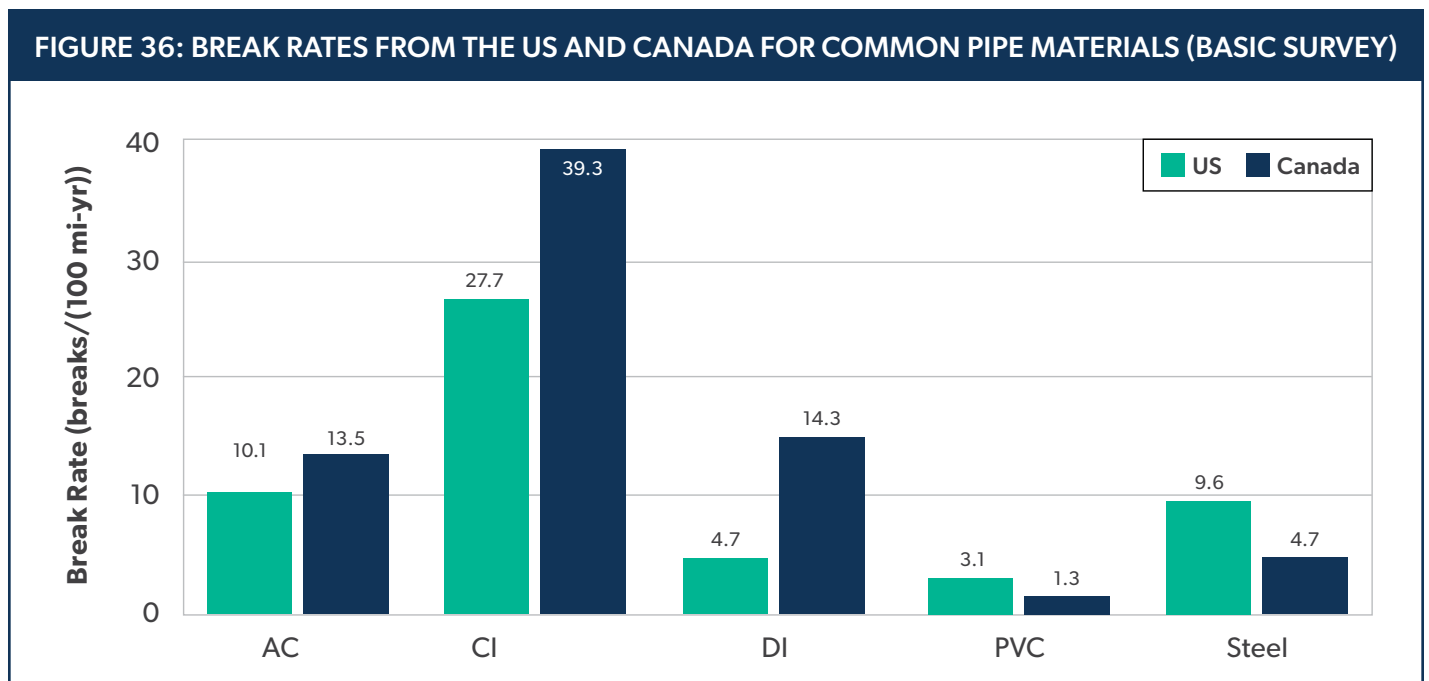
Figure 36 shows the break rates between US and Canada for the most common water pipe materials. It should be noted that portions of Canada have very corrosive soils and can have extremely cold weather. These factors could potentially explain the high Canadian break rates for CI and DI pipes (Seargeant, 2018).

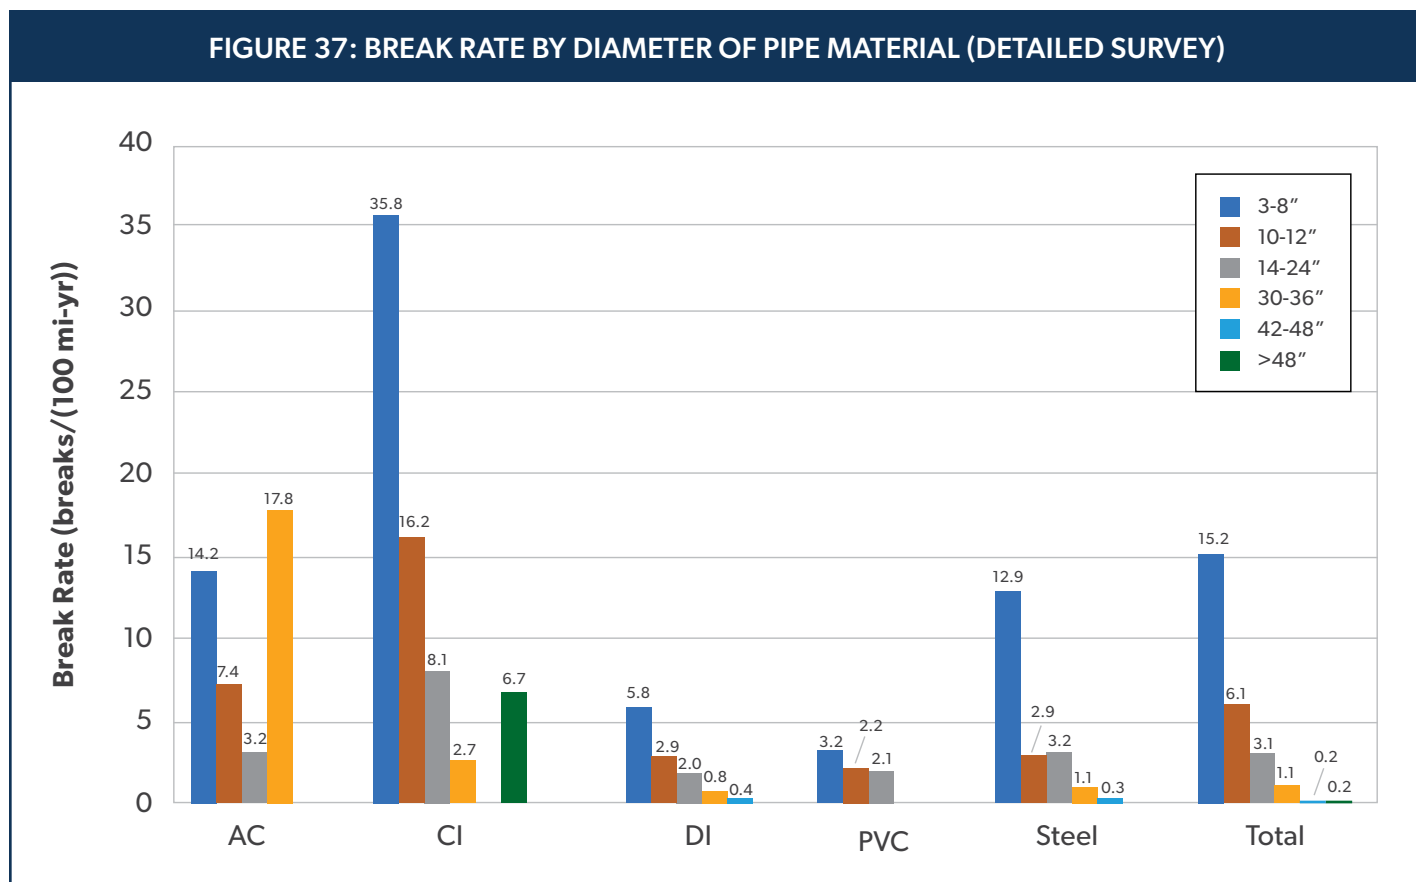
The detailed survey asked utilities for information on the size of different pipe materials in their water systems and their corresponding break rates. Figure 37 illustrates how the break rate changes as a function of pipe diameter. It is noteworthy that the break rate for all materials decreases as pipe diameter is increased. This is likely because of the greater effort put into installing, maintaining, and monitoring larger diameter pipes due to a higher consequence of failure. The higher break rates in larger diameters for AC and CI pipe are likely due to the low number of miles for these materials in this survey.

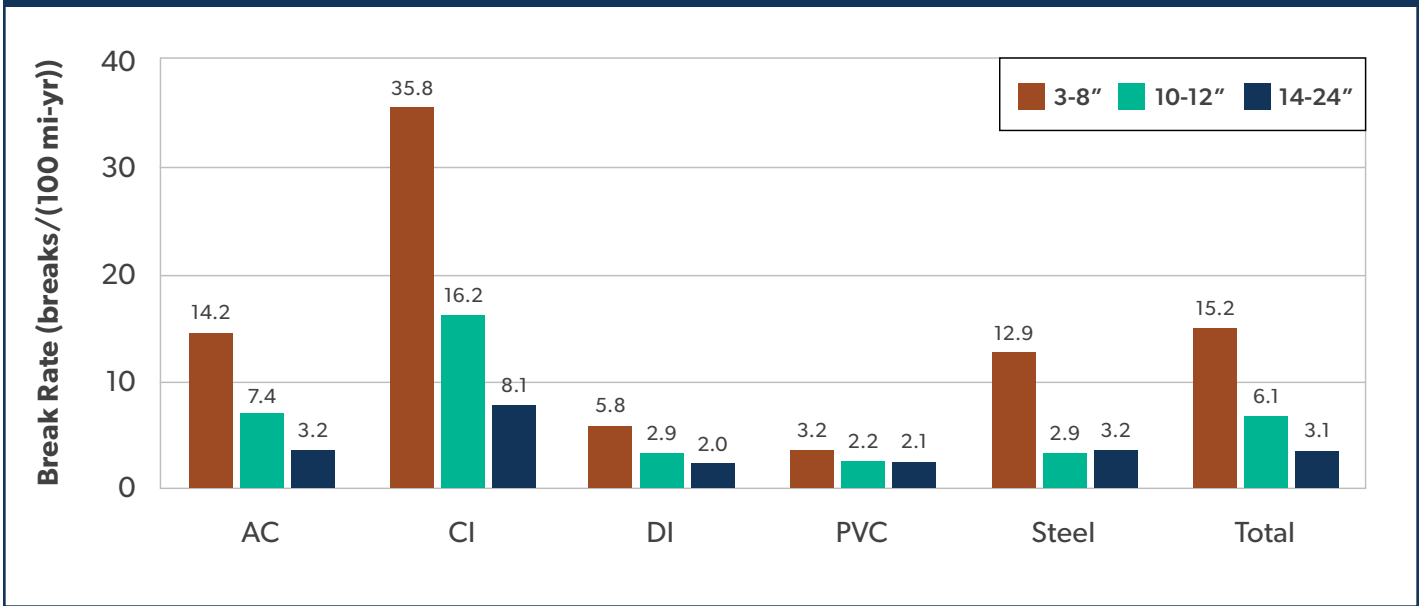
**FIGURE 38: BREAK RATES FOR 3- TO 8-INCH, 10- TO 12-INCH, AND 14- TO 24-INCH PIPE BY MATERIAL (DETAILED SURVEY)**

Figure 38 displays the break rates for the following size ranges: 3- to 8-inch, 10- to 12-inch, and 14- to 24-inch pipe. The objective is to focus more on the most used pipe diameters. The 14- to 24-inch sizes are commonly considered transmission mains, while 12-inch pipe and smaller is usually categorized as distribution pipe. Figure 23 indicates that 86% of all miles of water pipes are 3- to 12-inch in diameter, and a total of 68% are 3- to 8-inch in size.

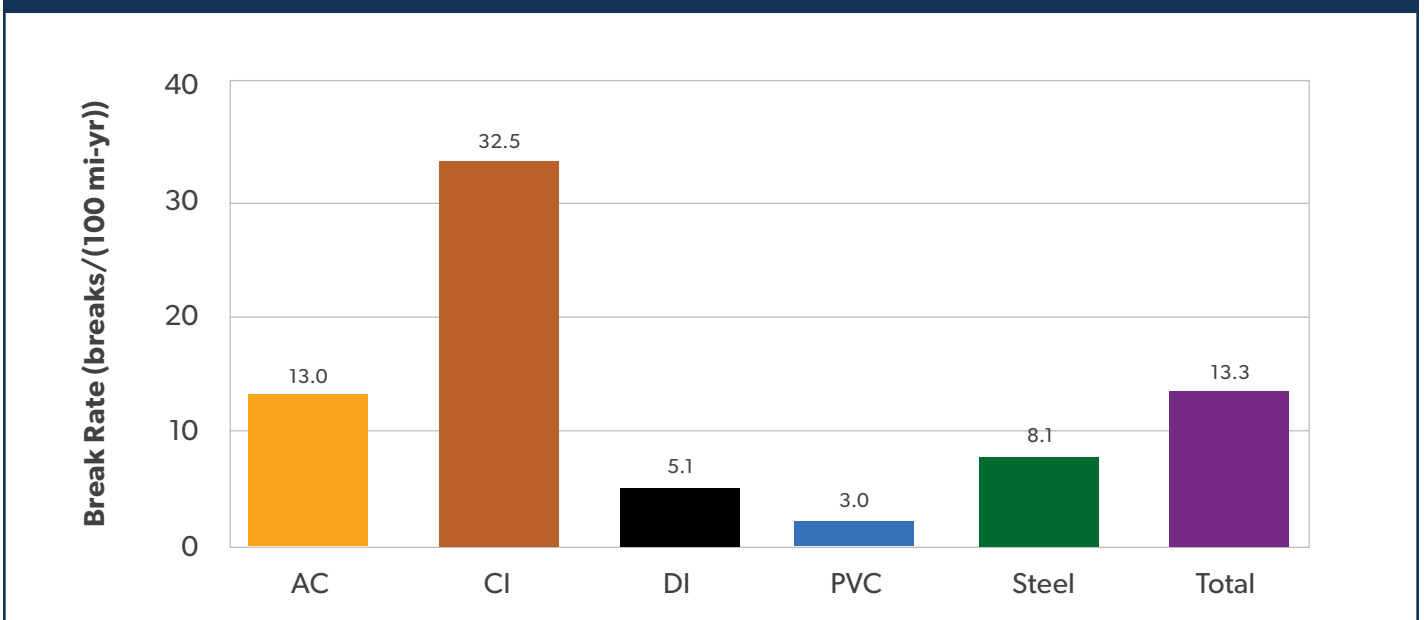
**FIGURE 39: BREAK RATES OF 3- TO 12-INCH PIPE BY MATERIAL (DETAILED SURVEY)**

Figure 39 illustrates the break rate of 3- to 12-inch pipe, while Figure 40 indicates the break rates of 3- to 8-inch pipe. Comparing these two figures shows a small difference in break rates. The 3- to 12-inch diameter range represents 86% of all pipe materials.

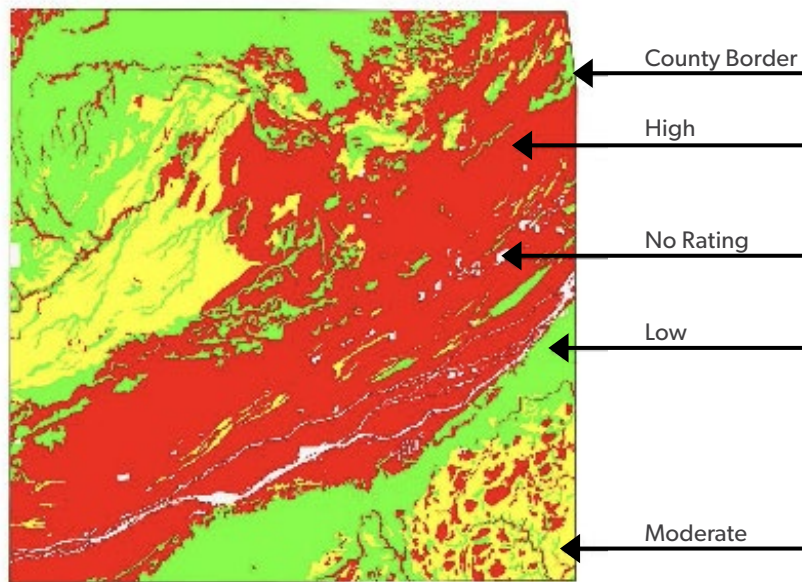
FIGURE 43: COUNTY MAP SHOWING CORROSIVE SOIL RISK

Corrosion index values were computed for 458 counties in the US. For example, the county shown in Figure 43 generated a corrosion index of 2.2, which is slightly above a moderate level. Some US counties had little or no data for the soils inside their boundaries, preventing determination of a corrosion index.

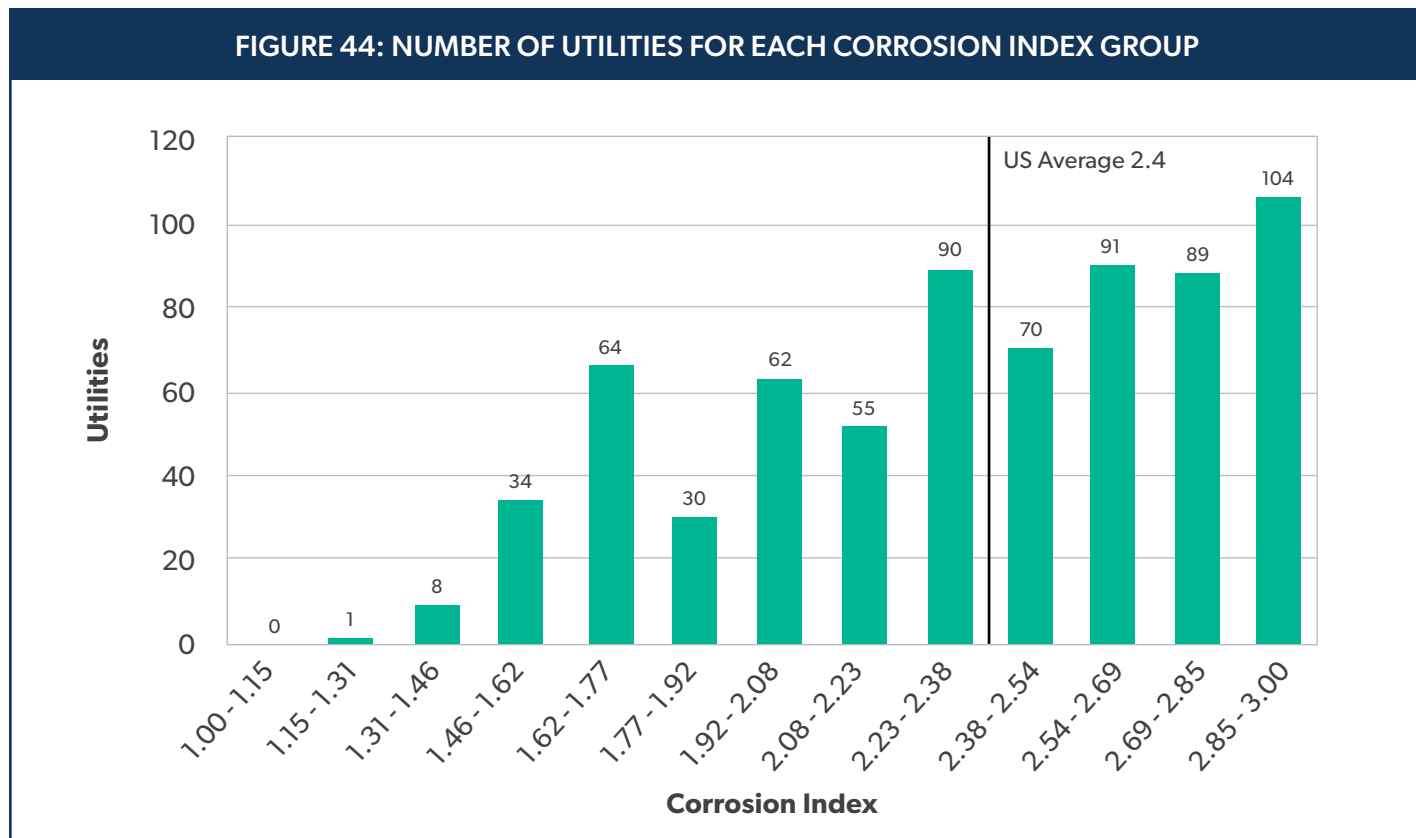
The corrosion index value calculated for each county was placed into one of thirteen range categories, shown in Figure 44.

The average corrosion index for all the US utilities in the basic survey was found to be 2.37 or close to midway between moderate and high corrosion risk. Notably, the overall corrosion index of the US from Figure 44 is 2.4. That is, most utilities in the US have a moderate to high soil corrosion risk, which is consistent with the detailed survey report that showed 75% of utilities have one or more areas with corrosive soil.

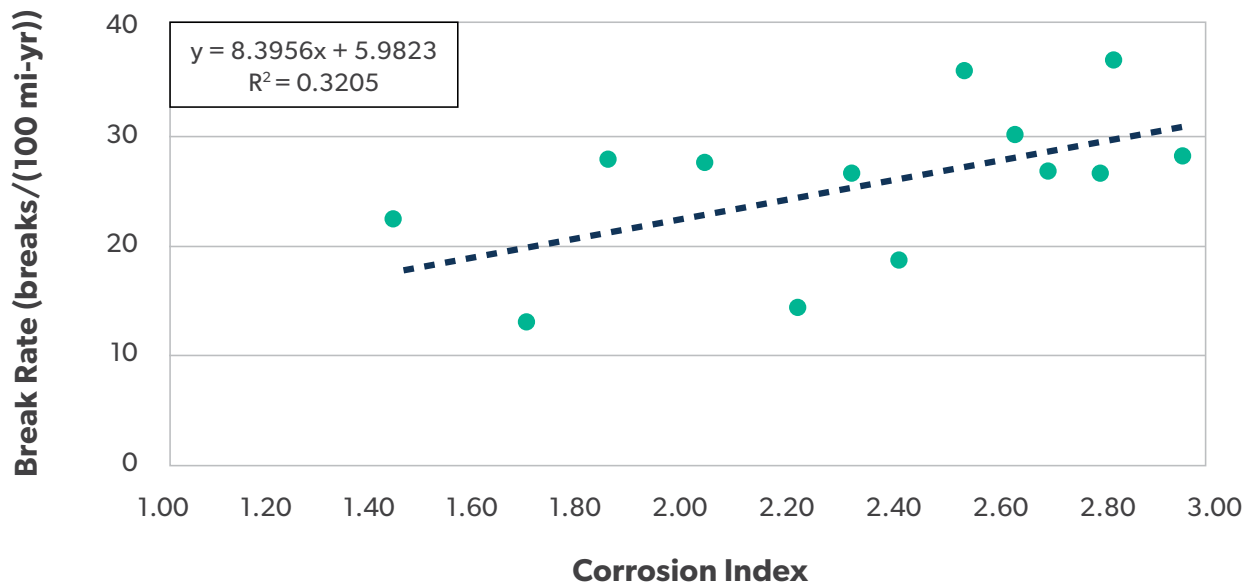
**FIGURE 45: CAST IRON PIPE BREAK RATE BY CORROSION INDEX (BASIC SURVEY)**

The slope of the line in Figure 45 demonstrates that CI pipe in highly corrosive soil (corrosion index of 3.0) is expected to have more than twice the break rate of one in low corrosive soil (corrosion index of 1.0). Similarly, Figure 46 shows that DI pipe in highly corrosive soil (corrosion index of 3.0) will have a break rate approximately six times greater than one in low corrosive soil (corrosion index of 1.0). Very poor correlations were found for all other pipe materials in this survey. It is understood that other factors not included in the survey may contribute to DI and CI pipe's failure rates.

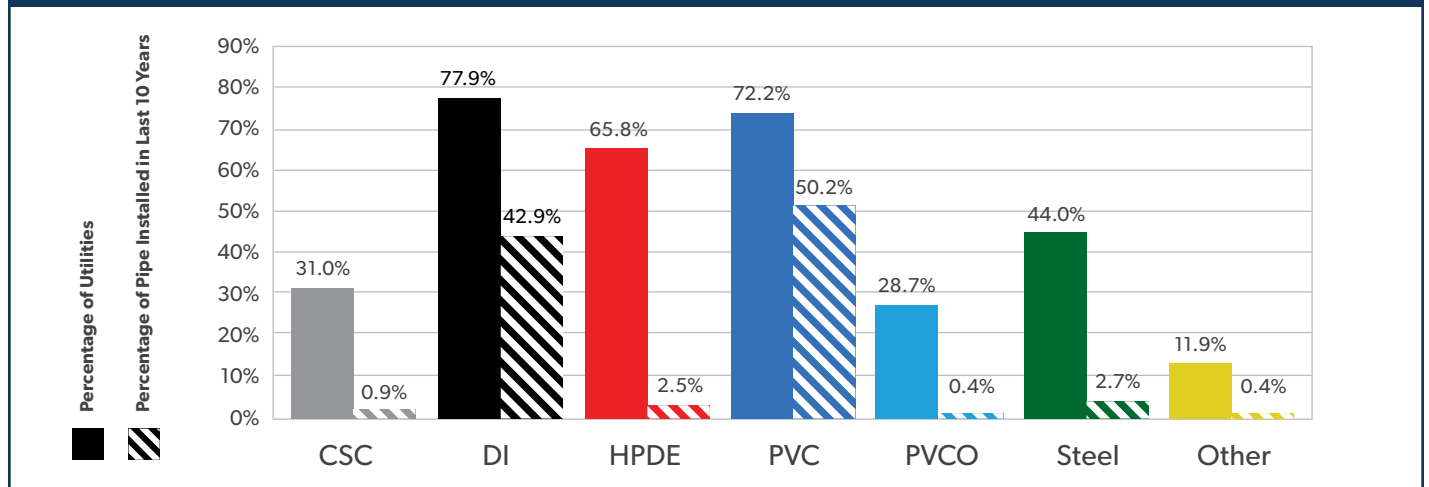
**FIGURE 48: PERCENTAGE OF UTILITIES ALLOWING USE OF WATER MAIN MATERIALS (DETAILED SURVEY)**

The detailed survey asked respondents what water main pipe materials are currently approved for use at their utility. Accepted pipe materials do not necessarily represent what is actually installed by a utility (Figure 12). Figure 48 illustrates the percentage of respondents that allow a particular pipe material to be installed (indicated by a solid bar).

For each material, the hashed bar represents the percent of total installed length over the last 10 years. For example, DI and PVC have a high acceptance rate and the most installed length. In contrast, HDPE is also commonly approved but only a small amount has been installed. Steel, CSC, and PVCO have both low acceptance rates and installed length. Pipe materials that have the largest difference between solid and hashed bars indicate that, although they may be accepted, they may only be used in specific applications.

- ▶ Percentage of utilities that allow use of different pipe materials: Section 9.0 (Figures 48 – 49)

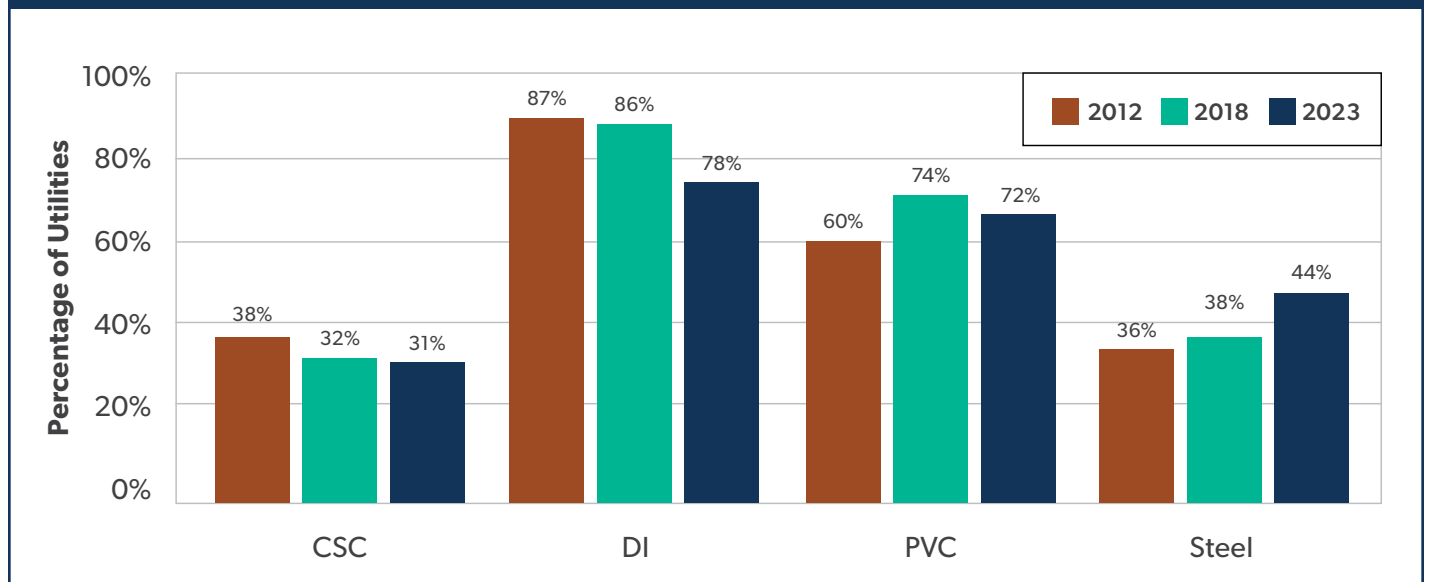
**FIGURE 49: COMPARISON WITH PREVIOUS SURVEYS FOR ALLOWED MATERIALS (DETAILED SURVEY)**

Figure 49 compares the pipe materials approved for use by utilities in the 2023 survey along with the data obtained in the 2012 and 2018 surveys; CI and AC are not listed because these materials are no longer manufactured. The number of utilities approving CSC and PVC pipes for use in water systems remained essentially the same as in 2018. The largest change is the 8% reported reduction in the acceptance of DI water pipe. The next largest change is the 6% increase in percentage of acceptance of steel pipe. It is important to note that HDPE and PVCO were not included in Figure 49 due to limited usage and data from the 2012 USU report. However, between 2018 and 2023, the percentage of acceptance for HDPE and PVCO did not significantly change. For comparison, Figures 17 through 19 illustrate actual pipe use across the three study periods by region.

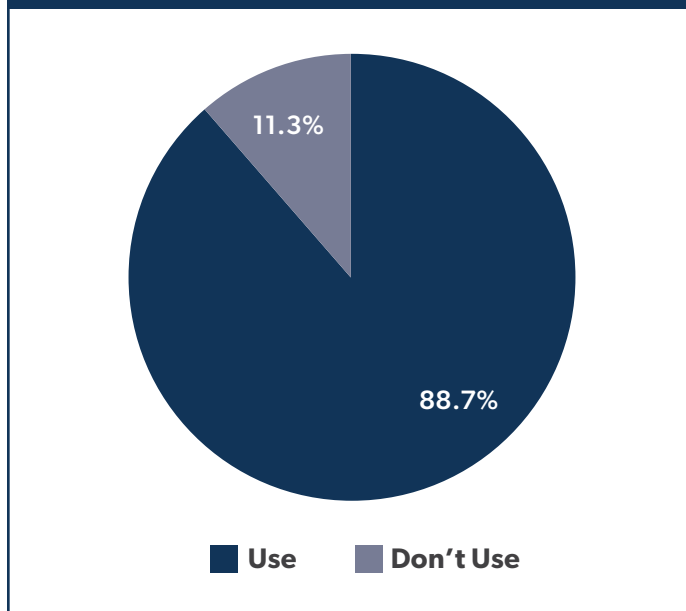
FIGURE 50: SURVEY QUESTION ON USE OF GIS (BASIC SURVEY)

An overall objective of the 2023 USU study is to provide water utilities and asset managers with additional insight to support improved water pipe asset management. The comprehensive nature of the 2023 survey and the participation of over 800 water utilities in the US and Canada alone suggests that since 2012 more water utilities have been collecting data on their water pipes. To accomplish this, water utilities have been populating underground water infrastructure data (linear assets) in a geographic information system (GIS). GIS is a core technology component of asset management and can be integrated as part of a larger work order computer maintenance management system (CMMS) or asset management system. When survey respondents were asked about their use of GIS, 88.7% confirmed GIS capabilities. Figure 50 illustrates the reported GIS users and nonusers.

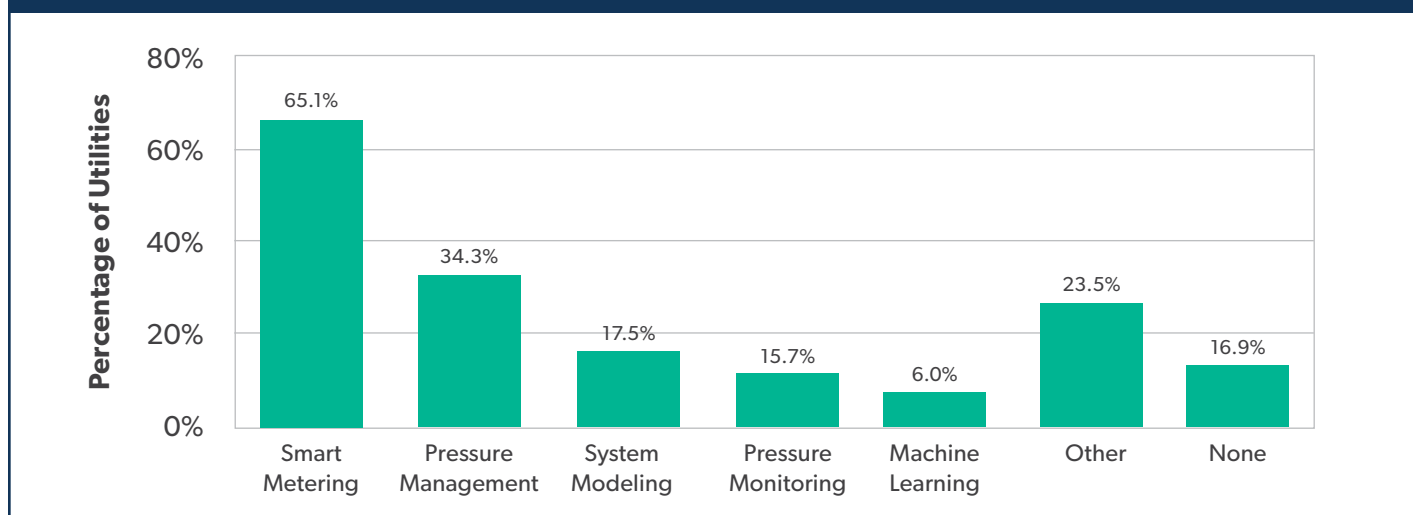
FIGURE 51: UTILITIES USING DIGITAL TECHNOLOGY IN ASSET MANAGEMENT (DETAILED SURVEY)

The detailed survey asked respondents about their usage of five different digital technologies: smart metering/advanced metering, system-wide pressure management, real-time system modeling, high-frequency pressure monitoring, and artificial intelligence/machine learning for condition assessment. The "Other" category includes technologies such as: leak detection, supervisory control and data acquisition (SCADA) software, risk modeling, etc. Figure 51 shows the percentage of utilities that use the listed technologies.
